MOMBASA SPECIAL ECONOMIC ZONE PROJECT
CONTRACT PACKAGE 1 – CIVIL AND BUILDING WORKS
(KPA/065/2022-23/PDM)

MONTHLY ENVIRONMENTAL MONITORING REPORT

DECEMBER 2025

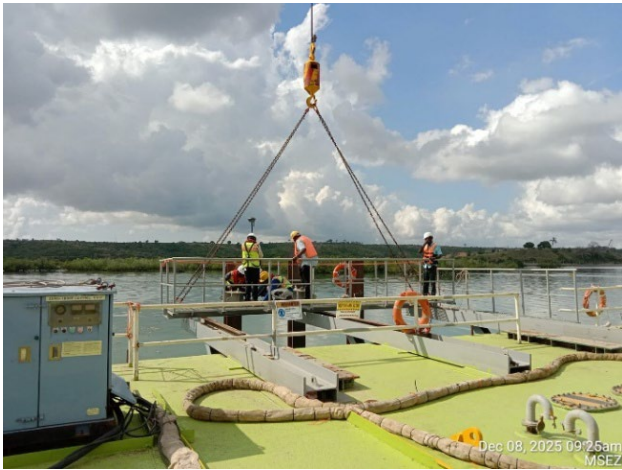
Setting out of Survey Platform 2

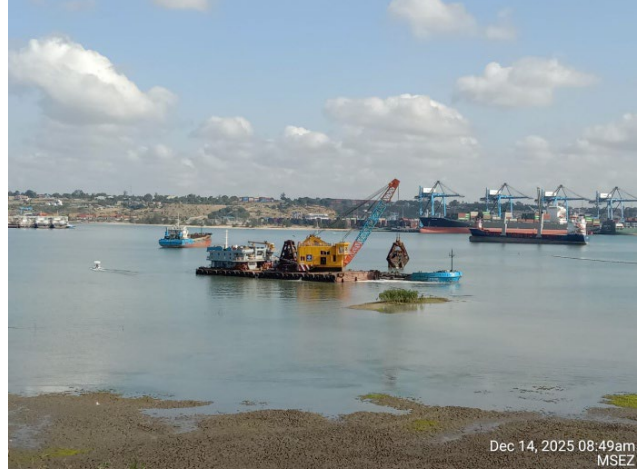
Dredging

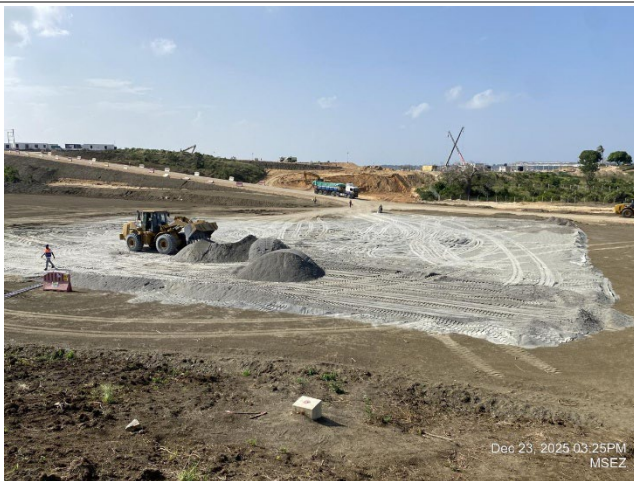
Rock sand stock piling

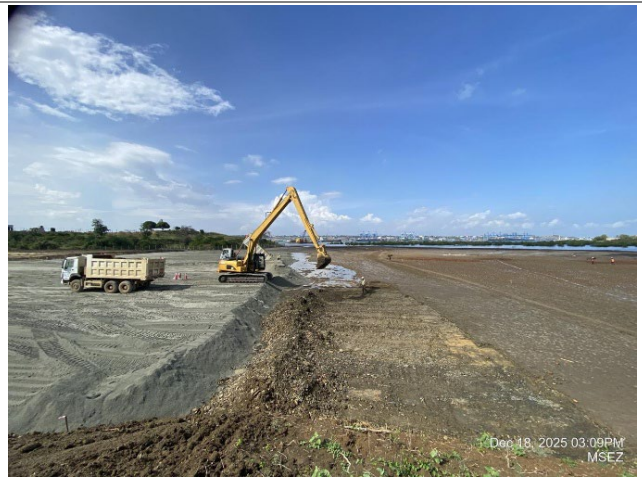
Topsoil stripping at Reclamation Yard

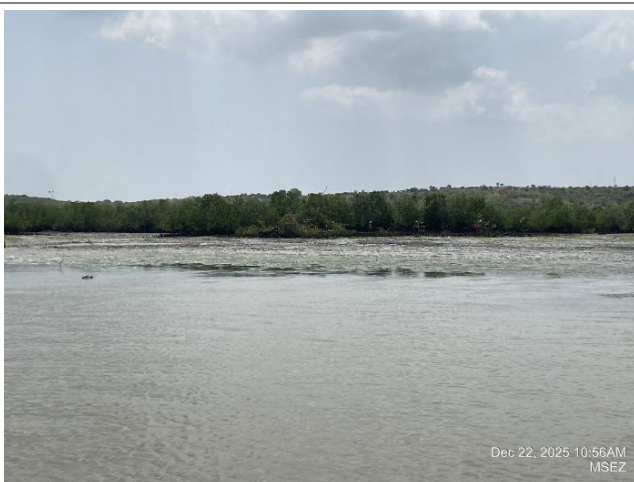
Mangrove clearance

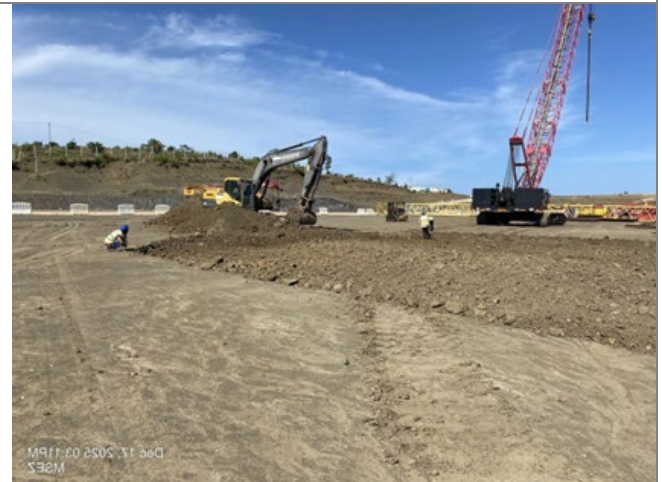
Precast yard preparation

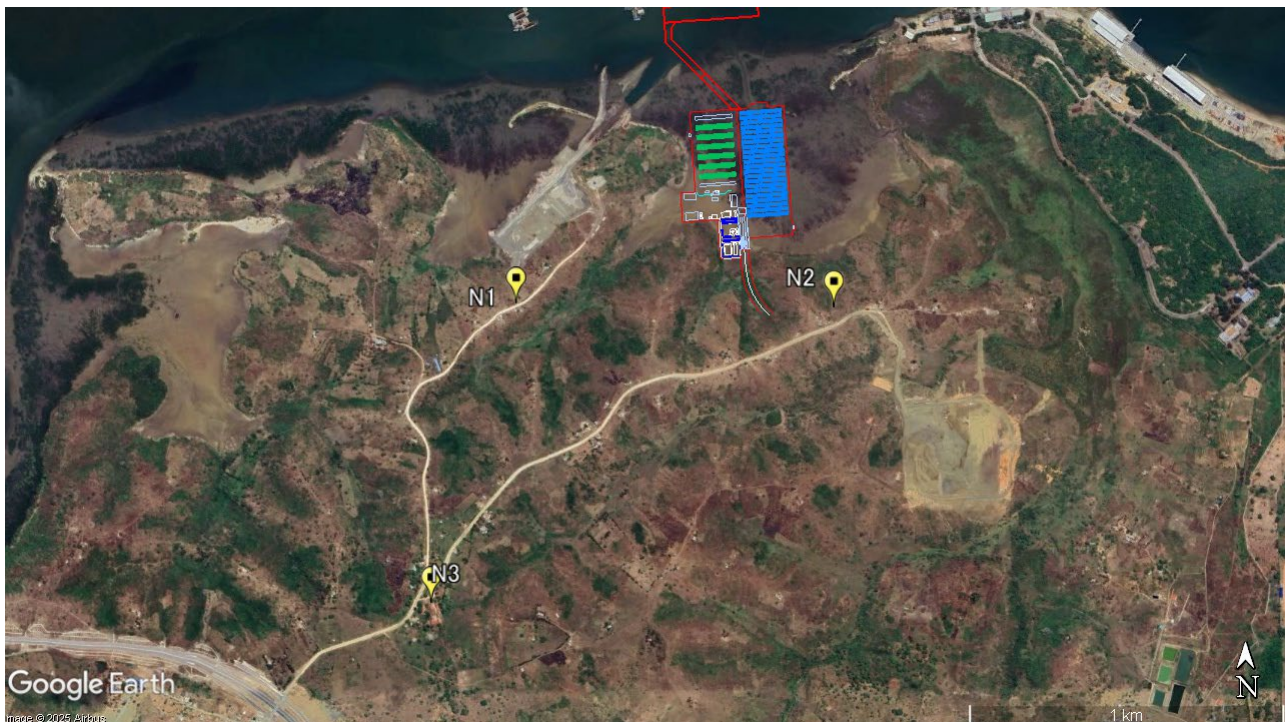
Figure 1 Noise Monitoring Sites

Table 5 outlines the method of noise monitoring. Figure 1 shows the noise monitoring sites.

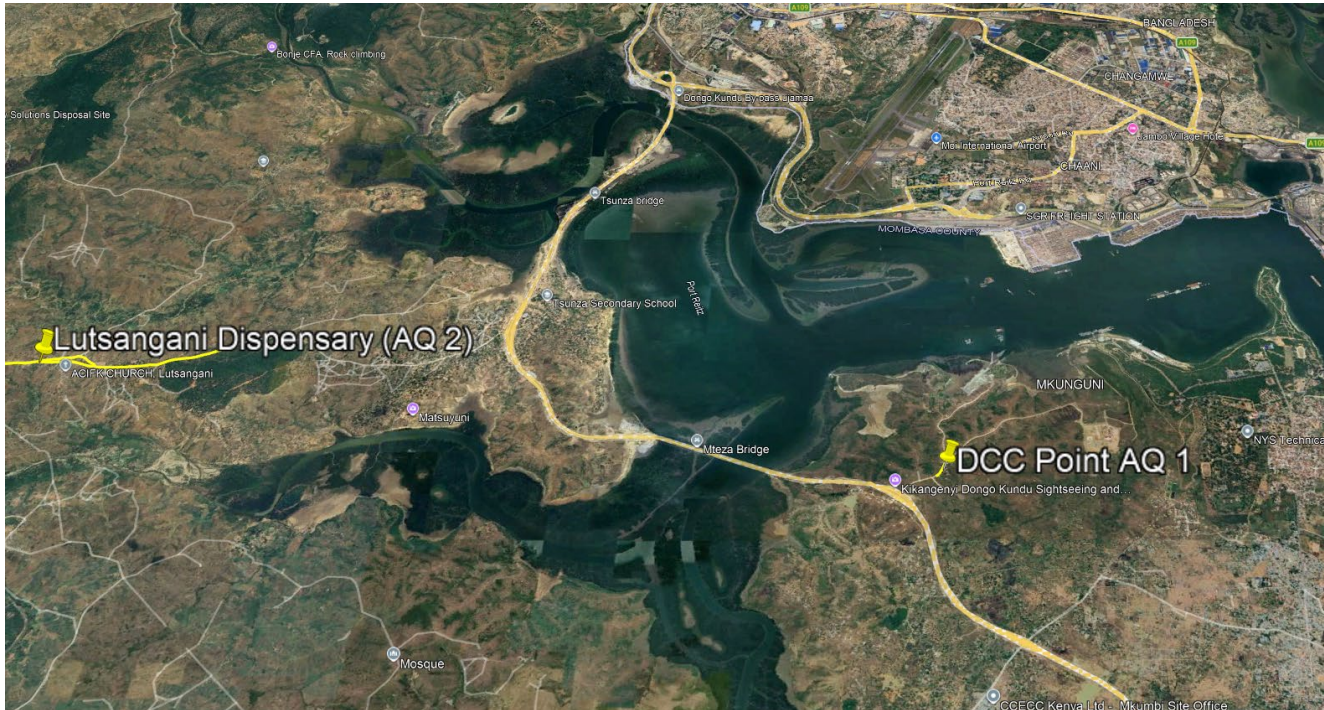
Figure 2 Air Quality Monitoring Sites

Table 7 Outlines the method of air quality monitoring while figure 2 shows the monitoring sites.

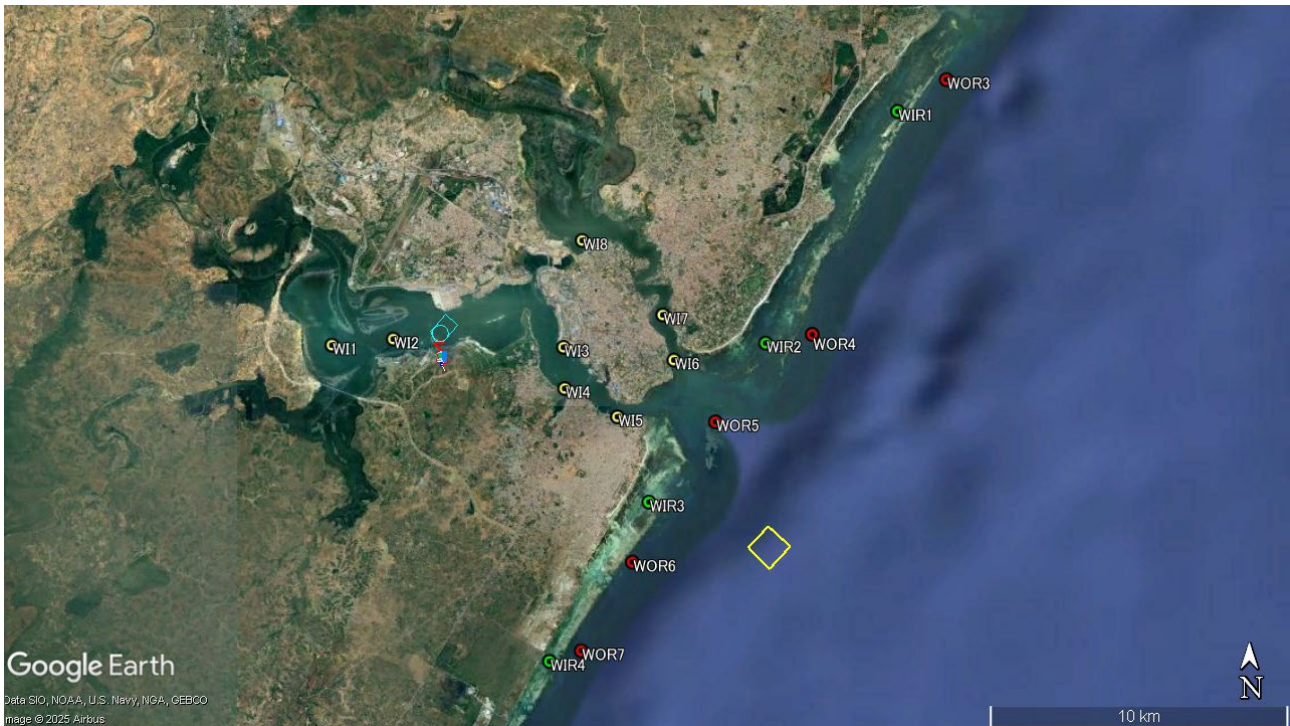
Figure 3 Turbidity Monitoring Sites

Table 9 outlines the method of turbidity monitoring. Figure 3 shows turbidity monitoring sites.

Table 14 shows the method of general water quality monitoring. The monitoring sites are the same as turbidity monitoring (see Figure 3).

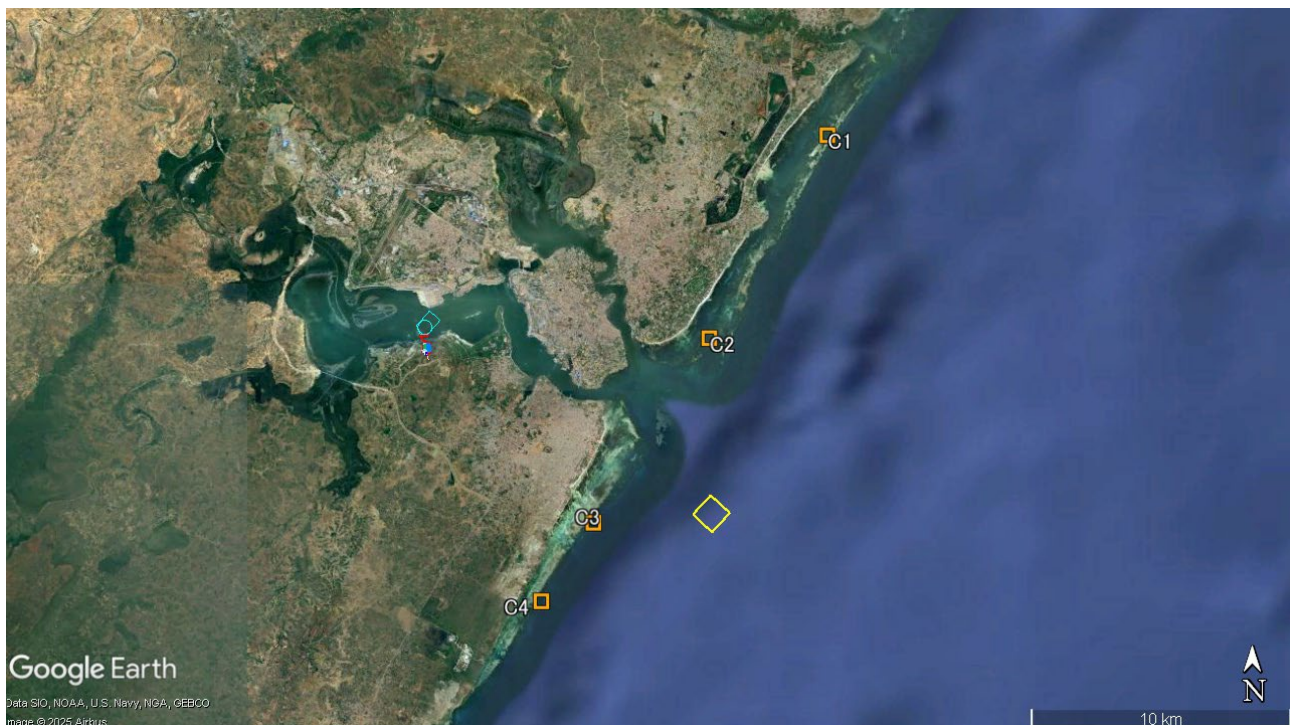
Figure 4 Coral monitoring sites

Table 17 outlines the method of coral monitoring. Figure 4 shows the coral monitoring sites.

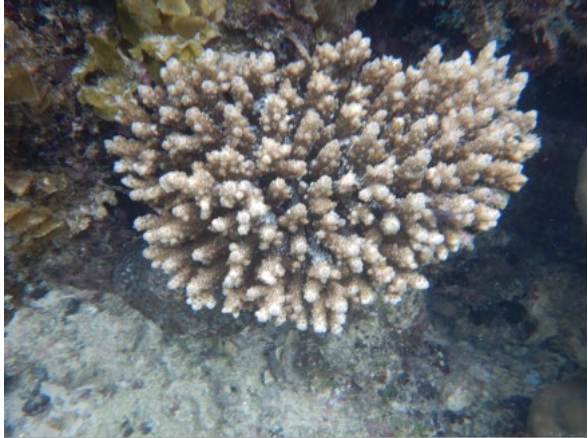
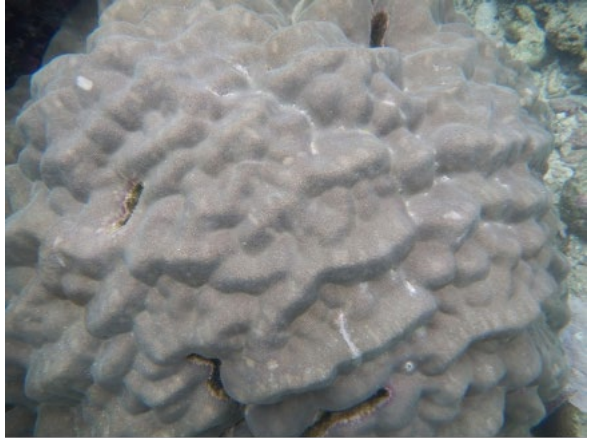
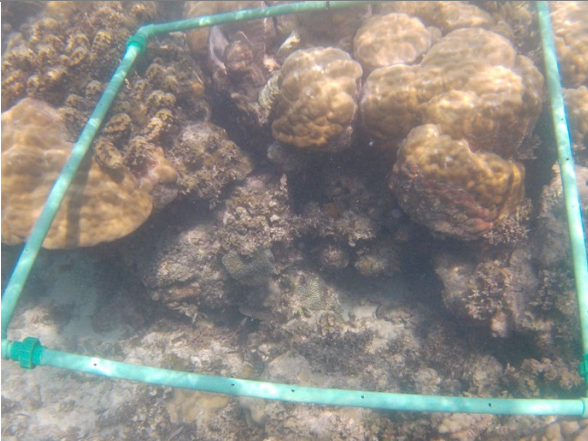
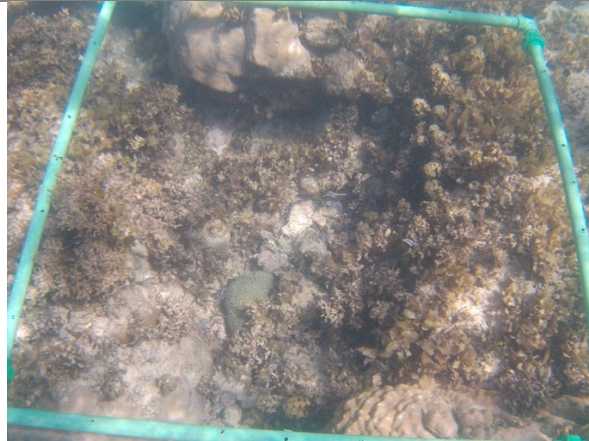
C1 – Coral Carden (Inner Reef)

Tables 18 and 19 show the results of coral monitoring. Coral monitoring results show an increase in sedimentation from low to medium.

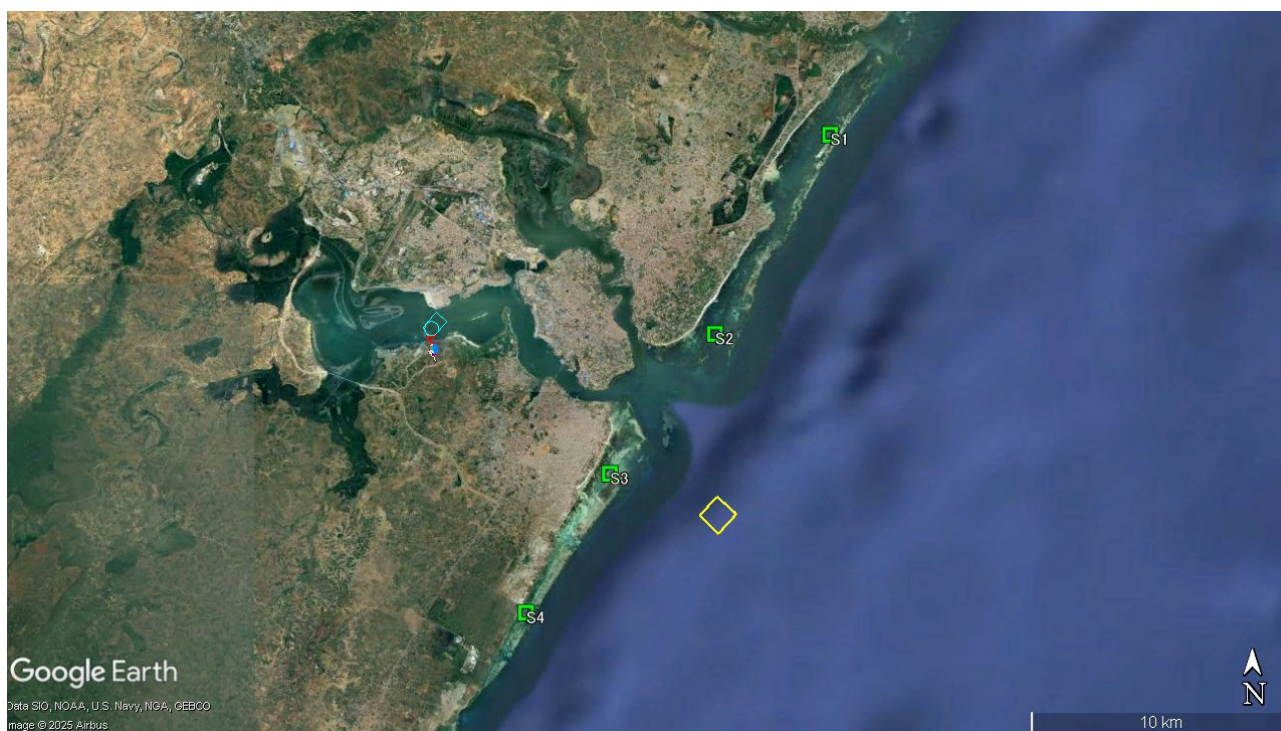
Figure 5 Seagrass Monitoring Sites

Table 20 outlines the method of seagrass monitoring. Figure 5 shows the seagrass monitoring sites.

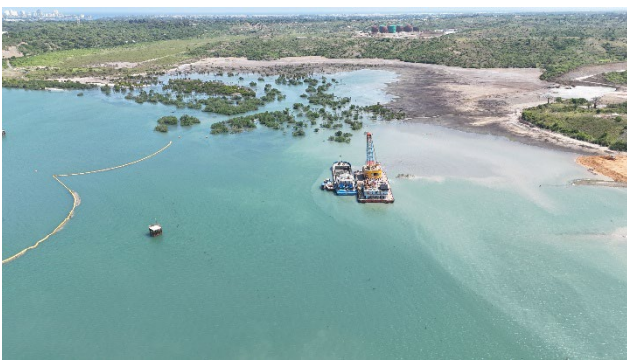
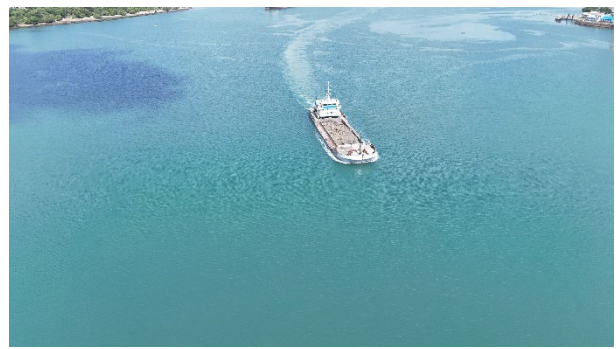
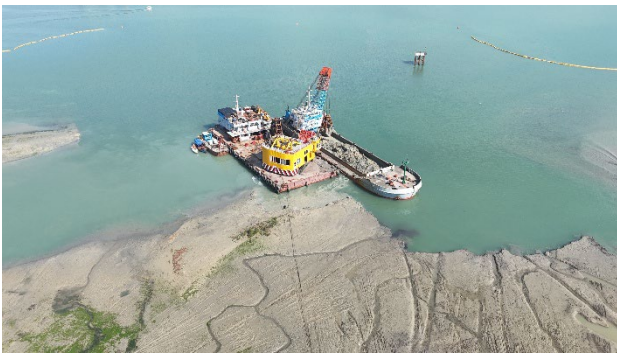
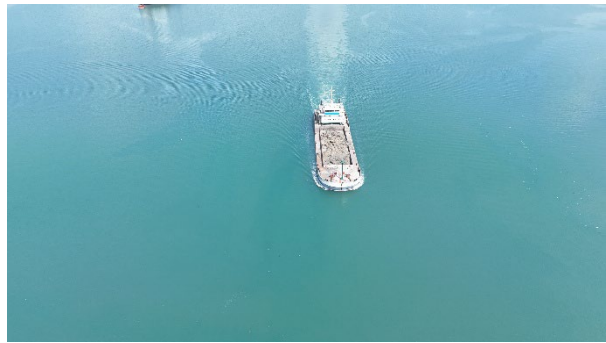
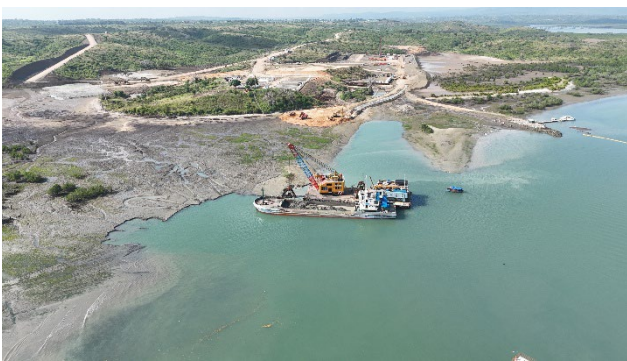
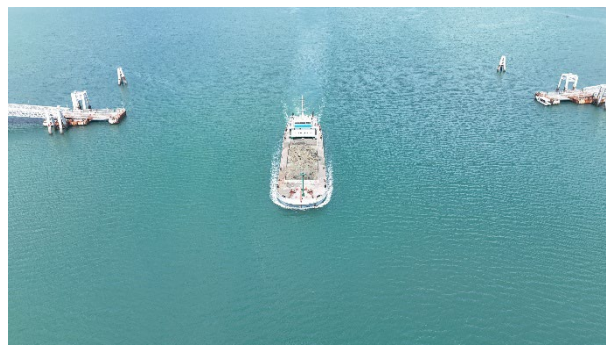
10.1 ANNEX A - DRONE IMAGES OF AERIAL TURBIDITY MONITORING

Date	Location	Exceedance of Ref. Standard (Y/N)*	Remedial Actions
19/12/2025	Dredging area	No	No exceedance of ref. standard hence no remedial actions triggered
19/12/2025	Kilindini	No	No exceedance of ref. standard hence no remedial actions triggered
