MOMBASA SPECIAL ECONOMIC ZONE PROJECT
CONTRACT PACKAGE 1 – CIVIL AND BUILDING WORKS
(KPA/065/2022-23/PDM)

MONTHLY ENVIRONMENTAL MONITORING REPORT

OCTOBER 2025

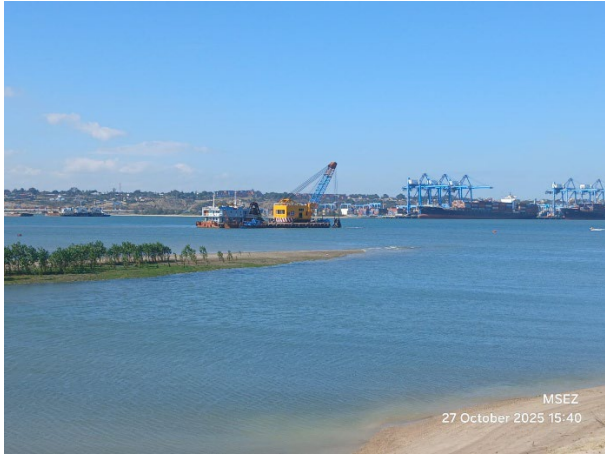
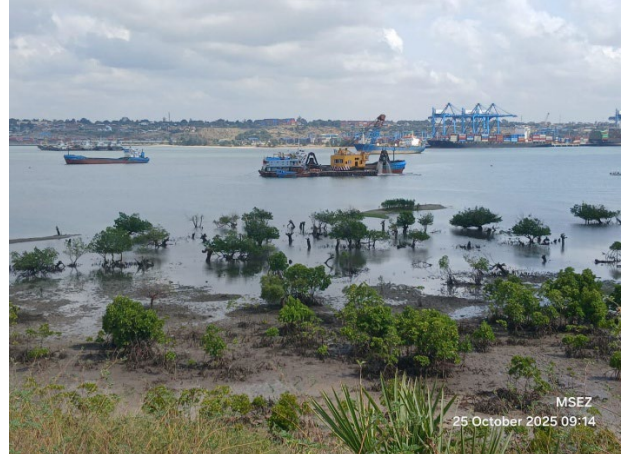
Dredging

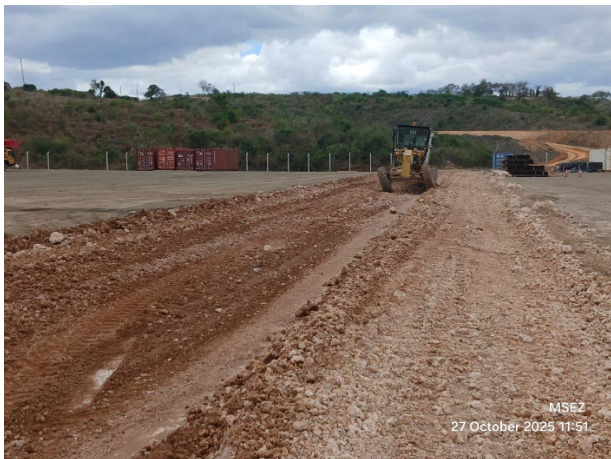
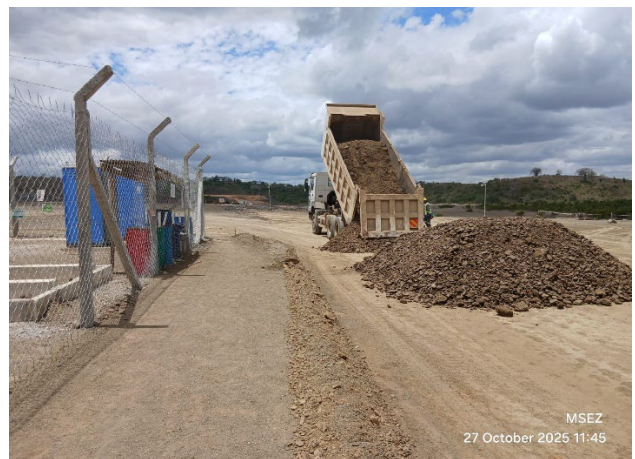
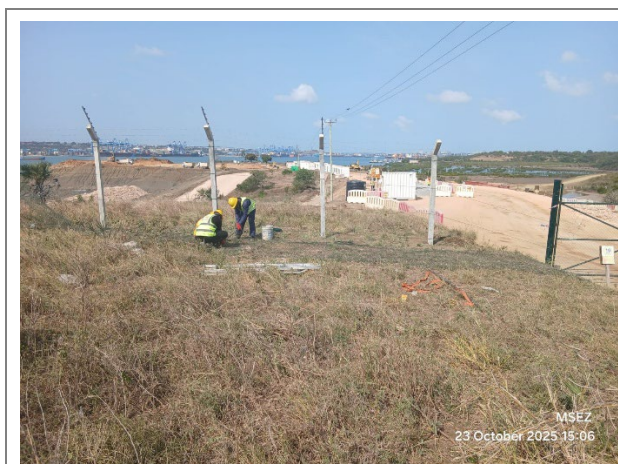
Temporary Access Road Construction

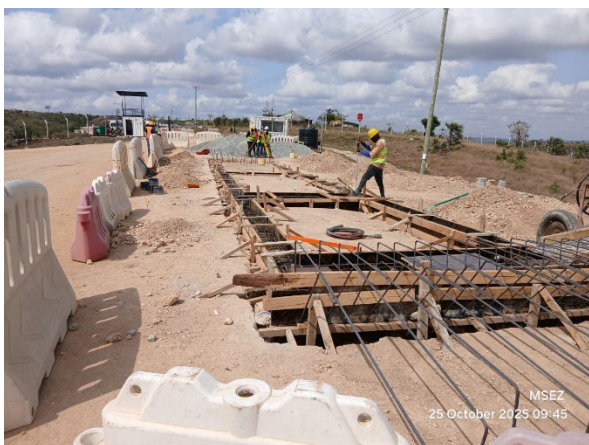
Weighbridge Construction

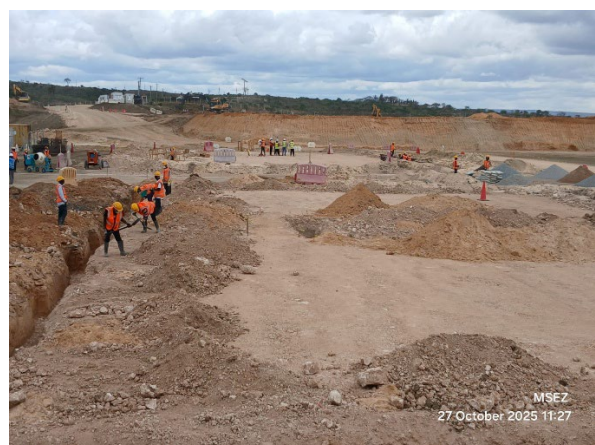
Contractor's Office & Canteen Construction

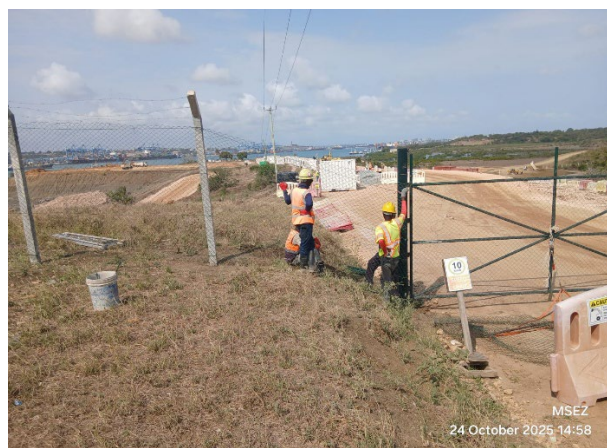
Gate Installation

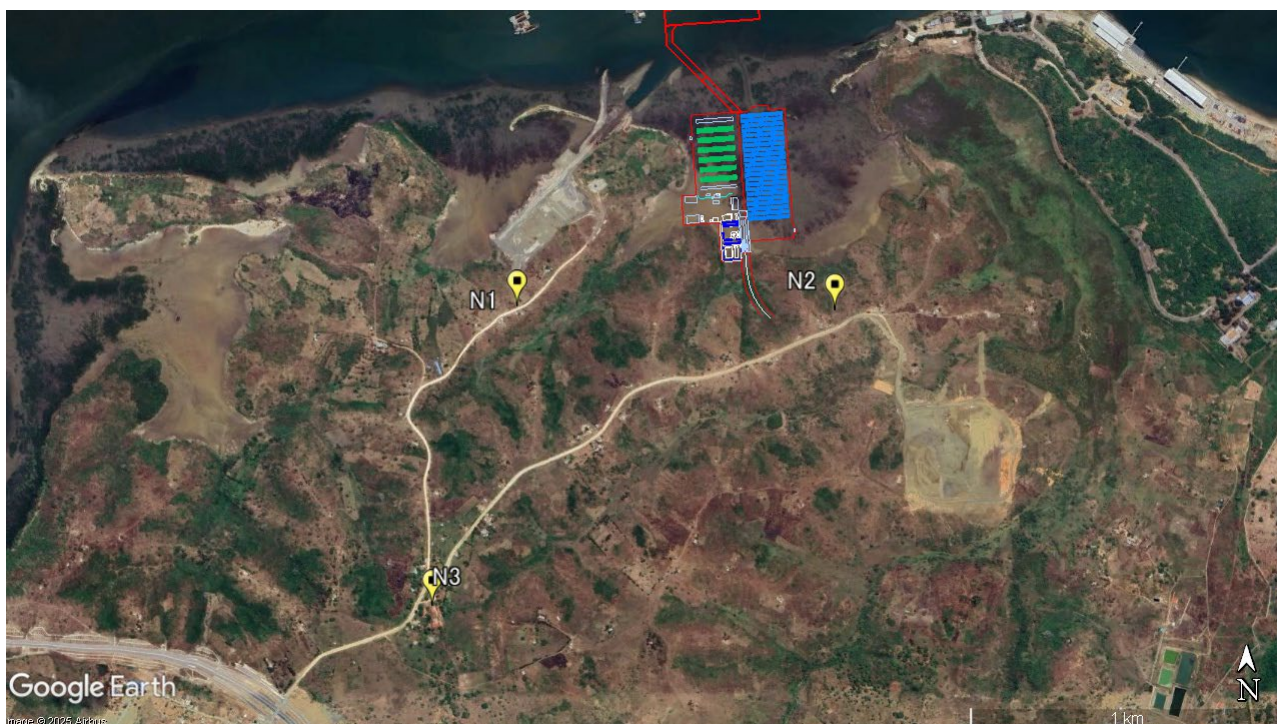
Figure 1 Noise Monitoring Sites

Table 5 outlines the method of noise monitoring. Figure 1 shows the noise monitoring sites. Note that monitoring at N3 was not implemented in the month of October as it was set out and agreed by the Engineer Representative to begin in the month of November 2025.

Table 6 shows the results of noise monitoring. Noise levels were below the reference standard at all the monitoring sites and days.

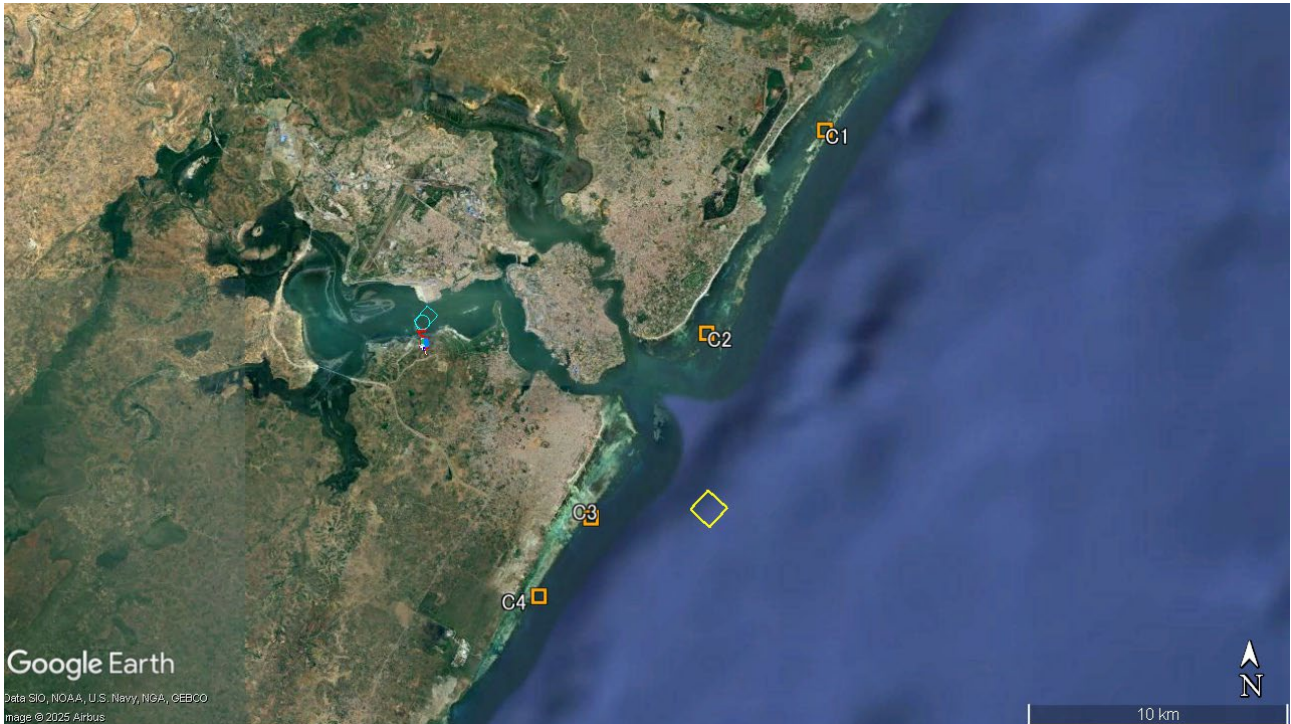
Figure 3 Coral monitoring sites

Table 13 outlines the method of coral monitoring. Figure 3 shows the coral monitoring sites.

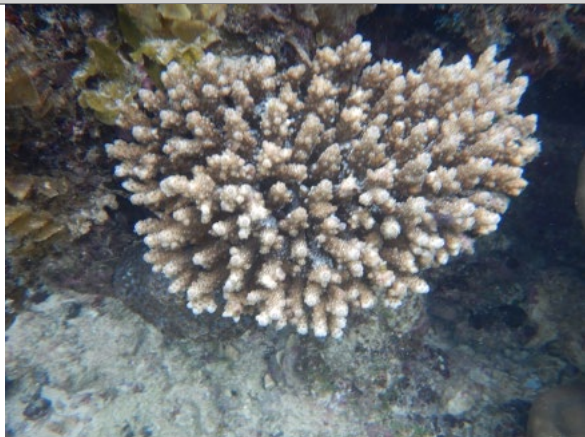
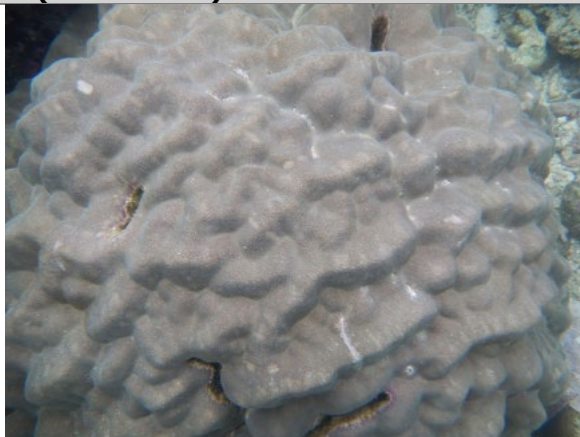
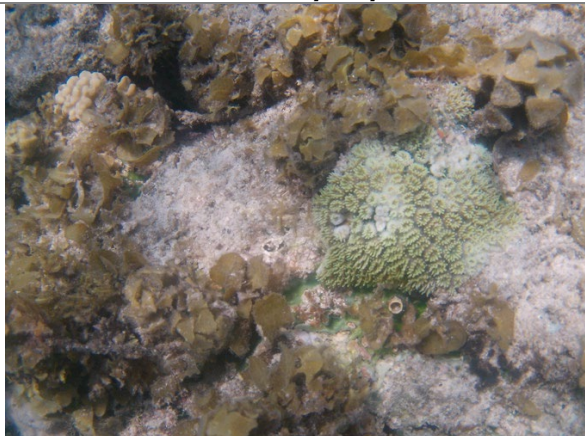
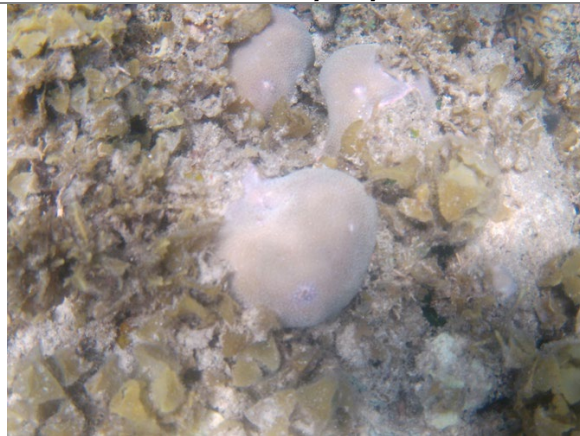
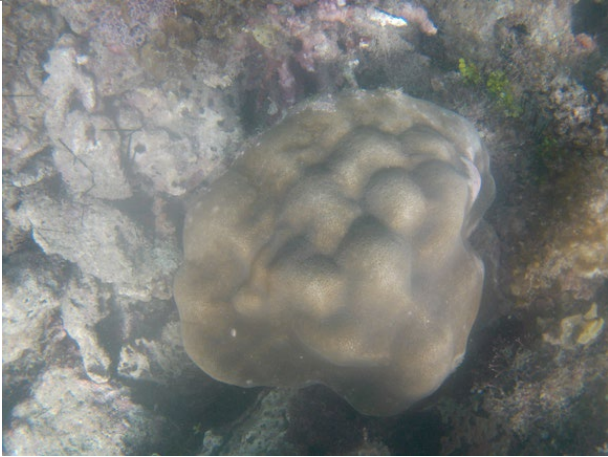
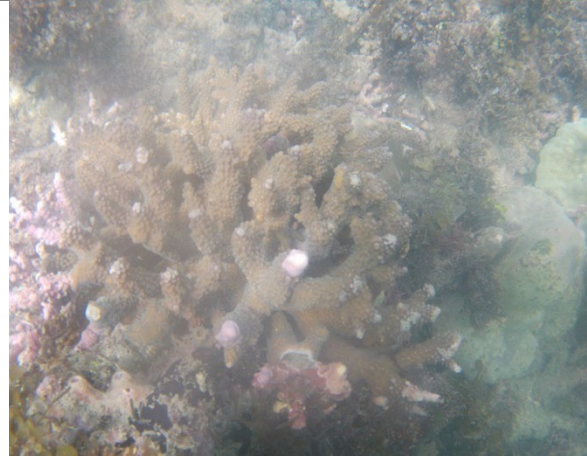
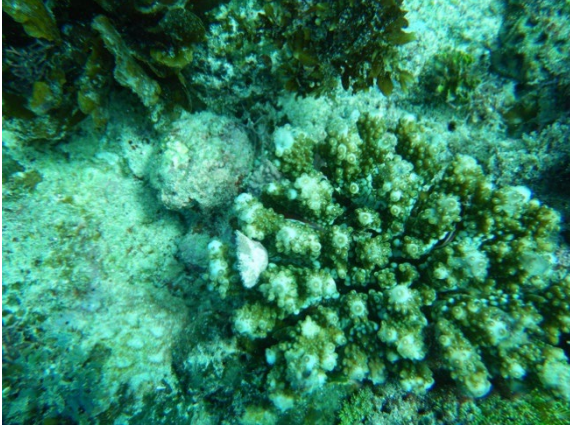
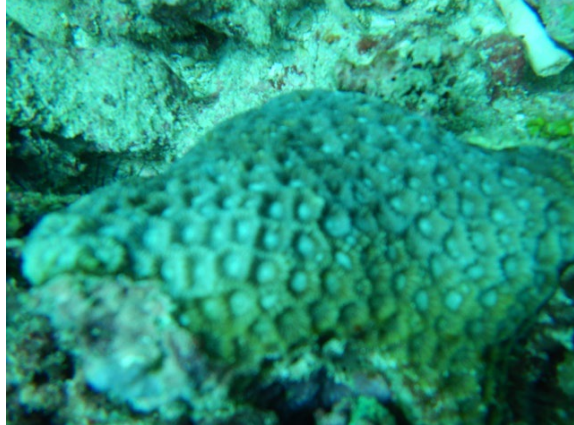
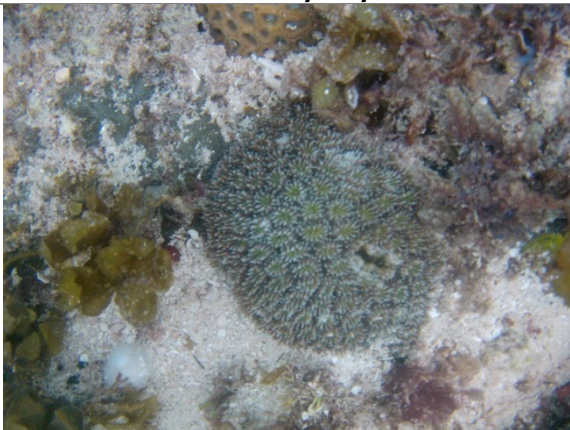
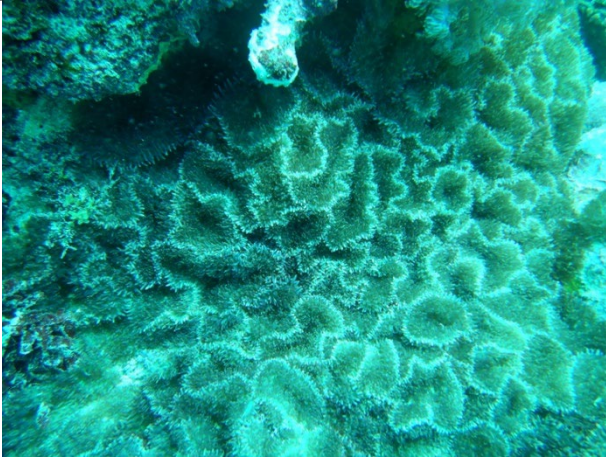
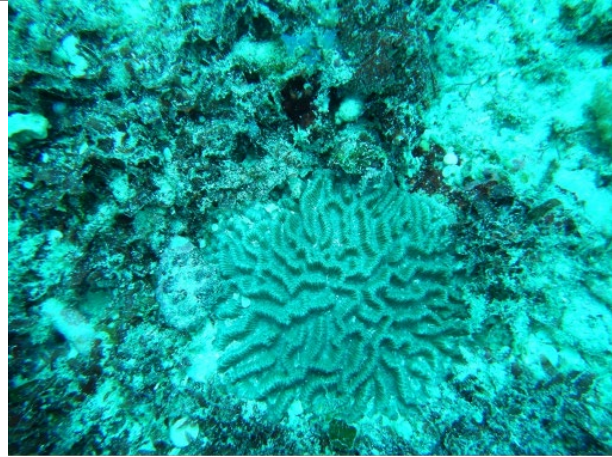
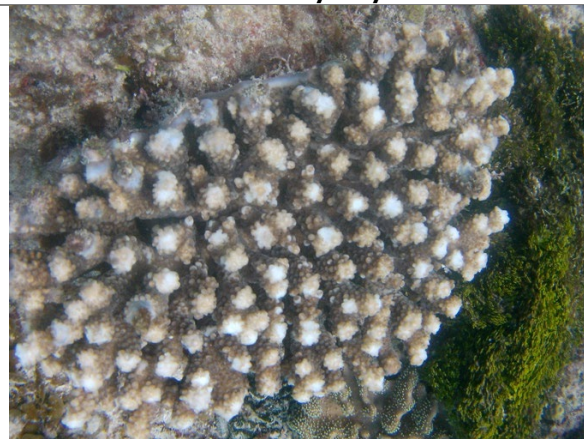
Table 15 Photos of Coral Monitoring

Coral monitoring results show that so far, there are no observable impacts on corals at the 4 monitoring sites. Collected empirical datasets and pictorial observations support this.

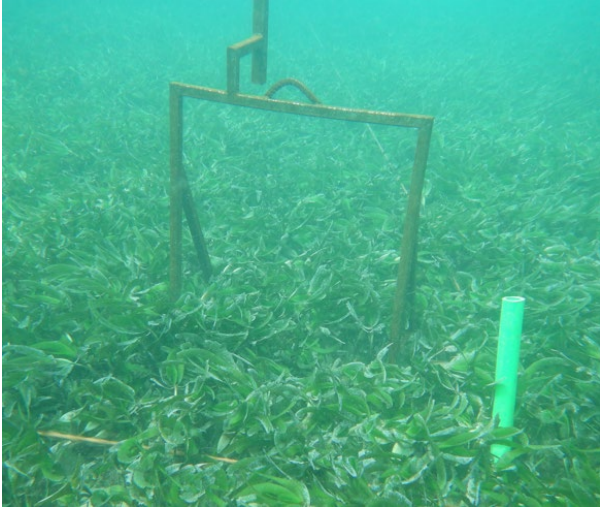
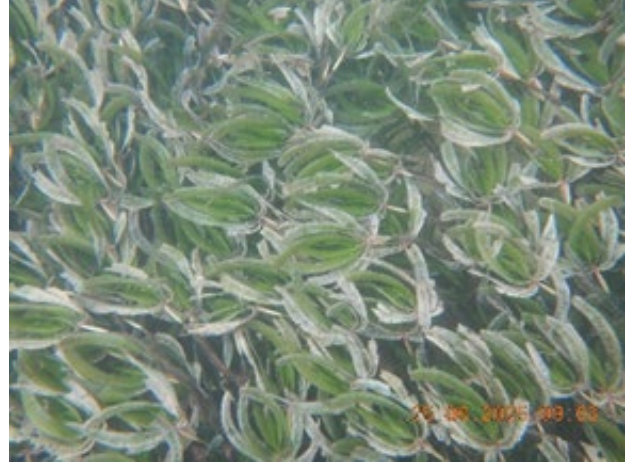
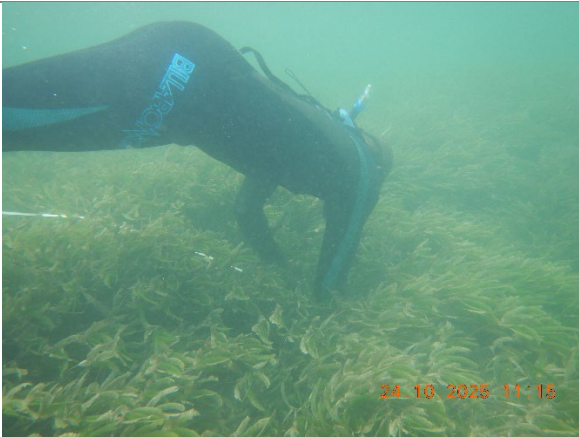
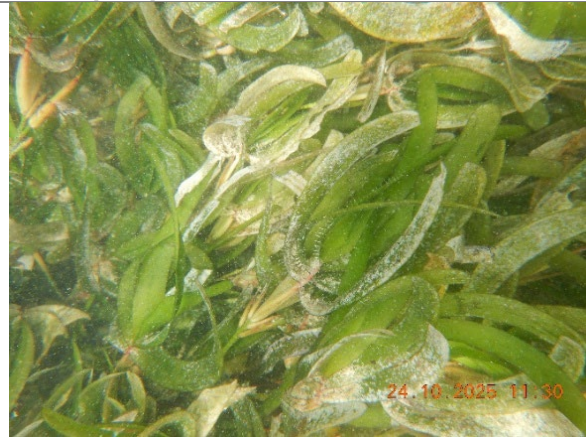
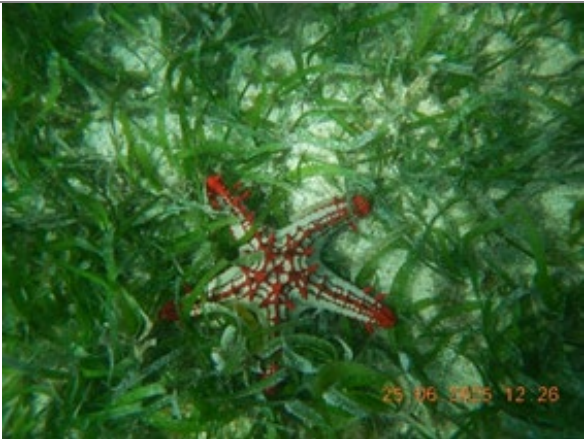
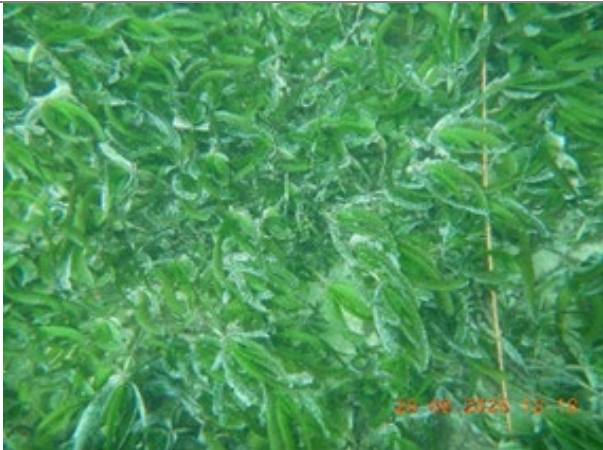
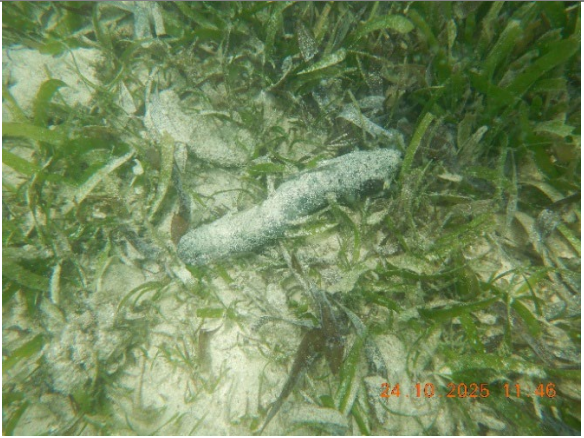
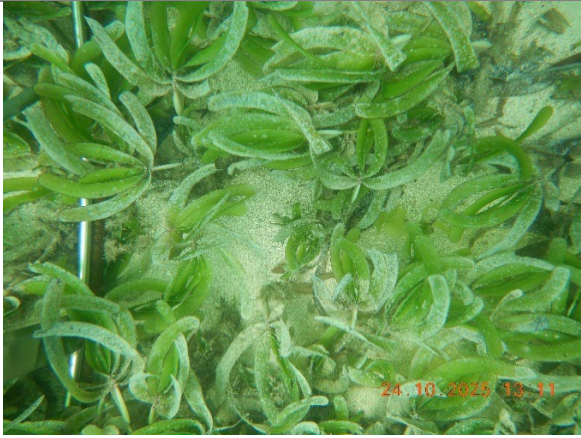
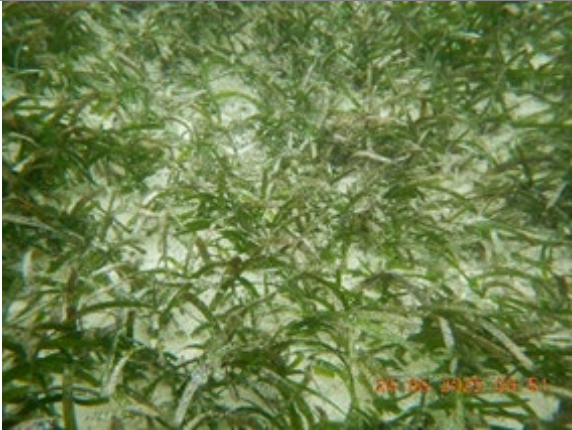
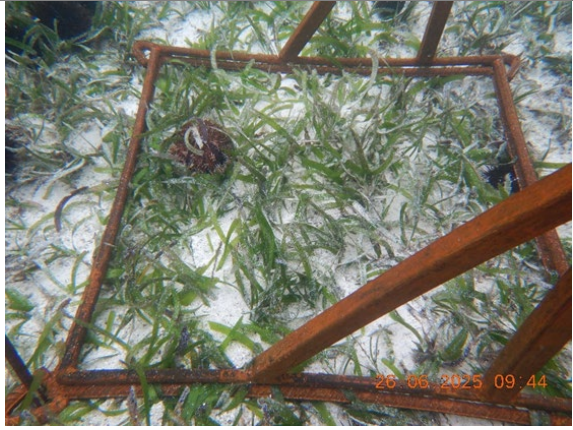
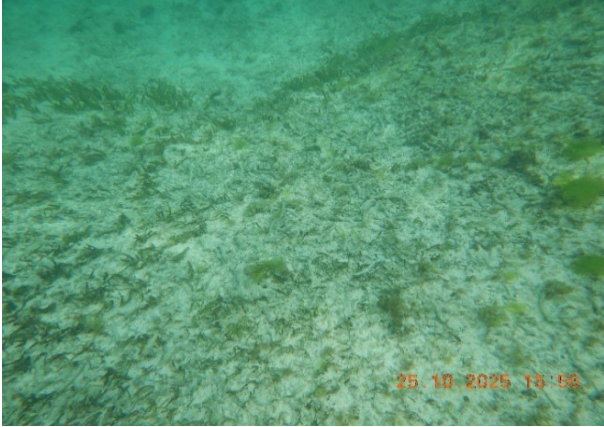
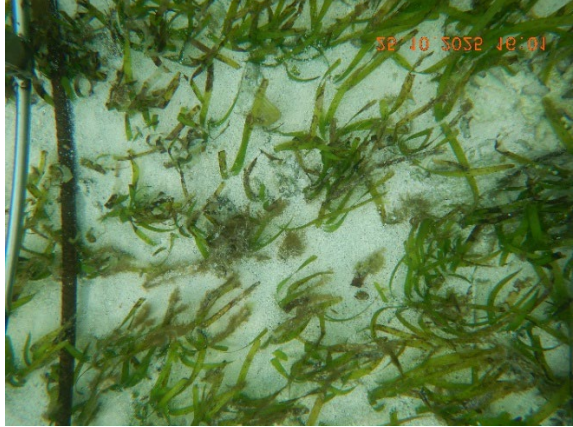
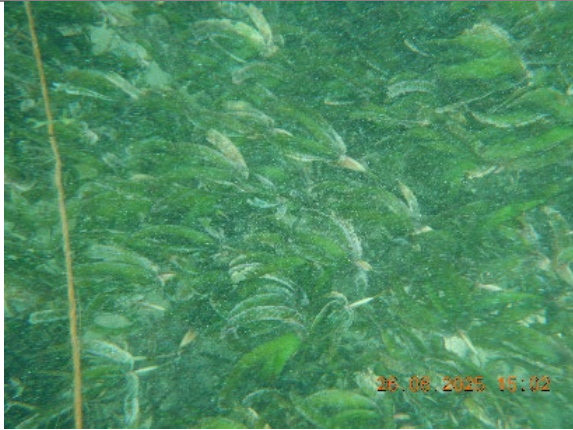
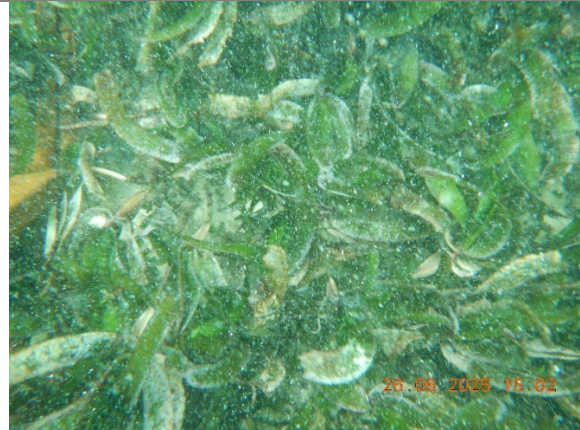
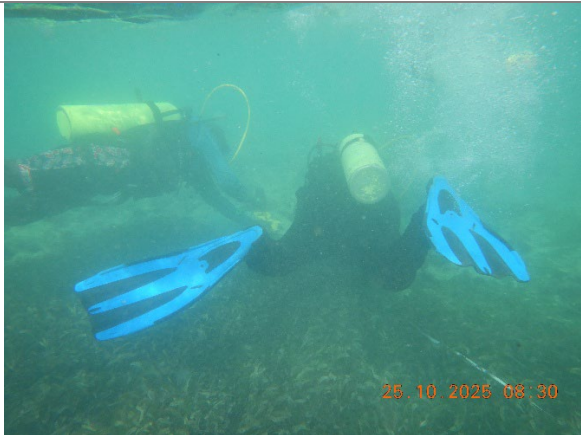
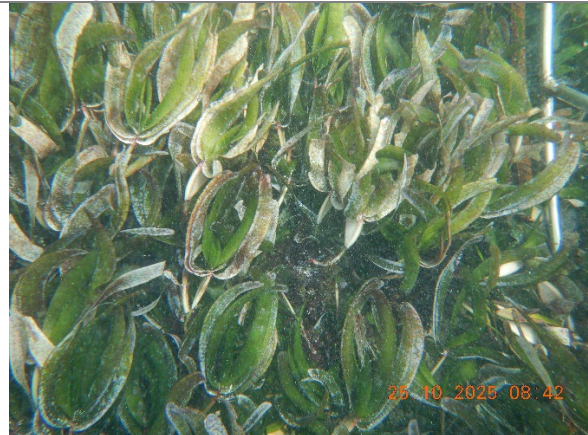
Table 18 Photos of Seagrass Monitoring

Seagrass monitoring results show that so far, there are no observable impacts on seagrass beds at the 4 monitoring sites. Collected empirical datasets and pictorial observations support this.
