CHINA COMMUNICATIONS CONSTRUCTION COMPANY
CCCC CONSTRUCTION OF BERTH 19B AND ASSOCIATED
INFRASTRUCTURE

4TH MONTHLY ENVIRONMENTAL MONITORING REPORT

20TH October – 19TH November 2025

Environmental Management and Monitoring Plan for Civil and Construction Works at Mombasa Port Berth 19B and Associated Infrastructure

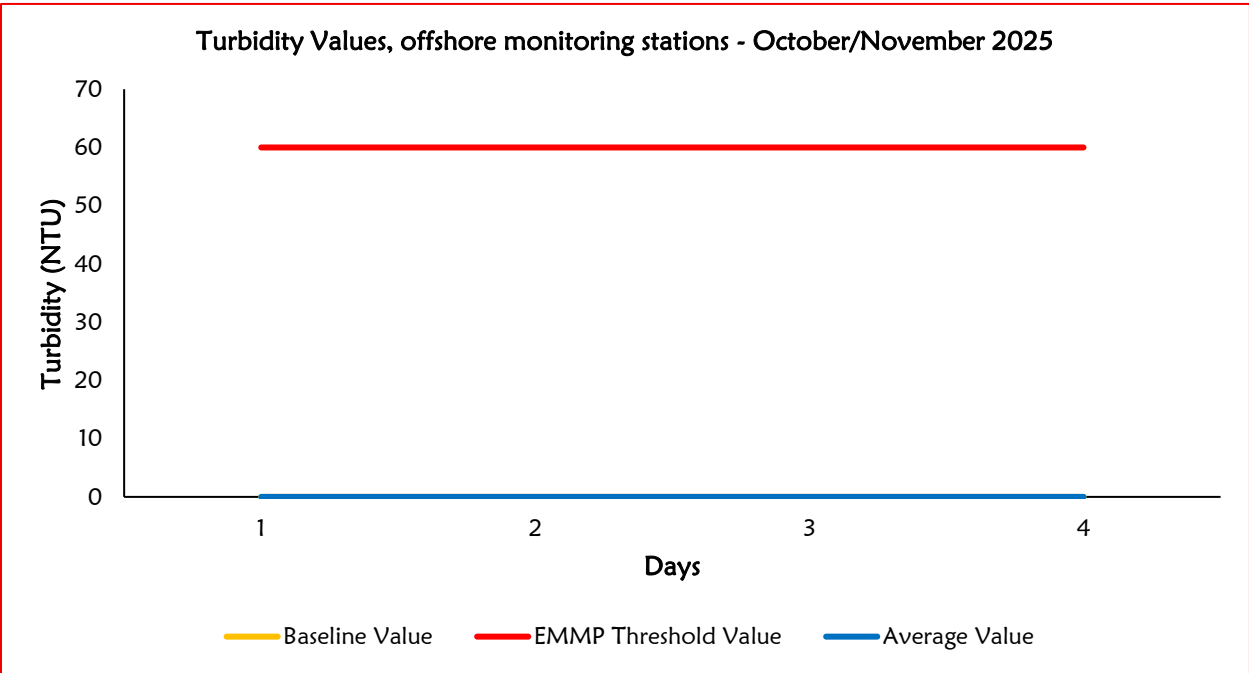
Figure 1: Turbidity values for onshore and offshore monitoring stations for the month of October/November 2025. The average value is the mean turbidity at -0.5m, -3.0m and -8.0m for the inshore and offshore monitoring stations (Data source: Lahvens Limited, October/November 2025).

This section presents the results for water quality monitoring for both the inshore monitoring stations (MS1-3) and offshore monitoring stations (MS4-8) for the monthly report period. These are summarized in Table 1 and 2 below and the summary of the raw data pooled for both the inshore and offshore monitoring stations for the entire month (Table 3). Both the physical water quality parameters i.e. pH, Dissolved Oxygen (DO) and turbidity, and the chemical water quality parameters i.e. Total Suspended Solids (TSS), Chemical Oxygen Demand (COD) and Perspective Degree were reported. Offshore monitoring stations reported insignificant change in parameters and the records are within the EMMP threshold value. All the inshore and offshore results are within the EMMP threshold values (Figure 1 and 2).

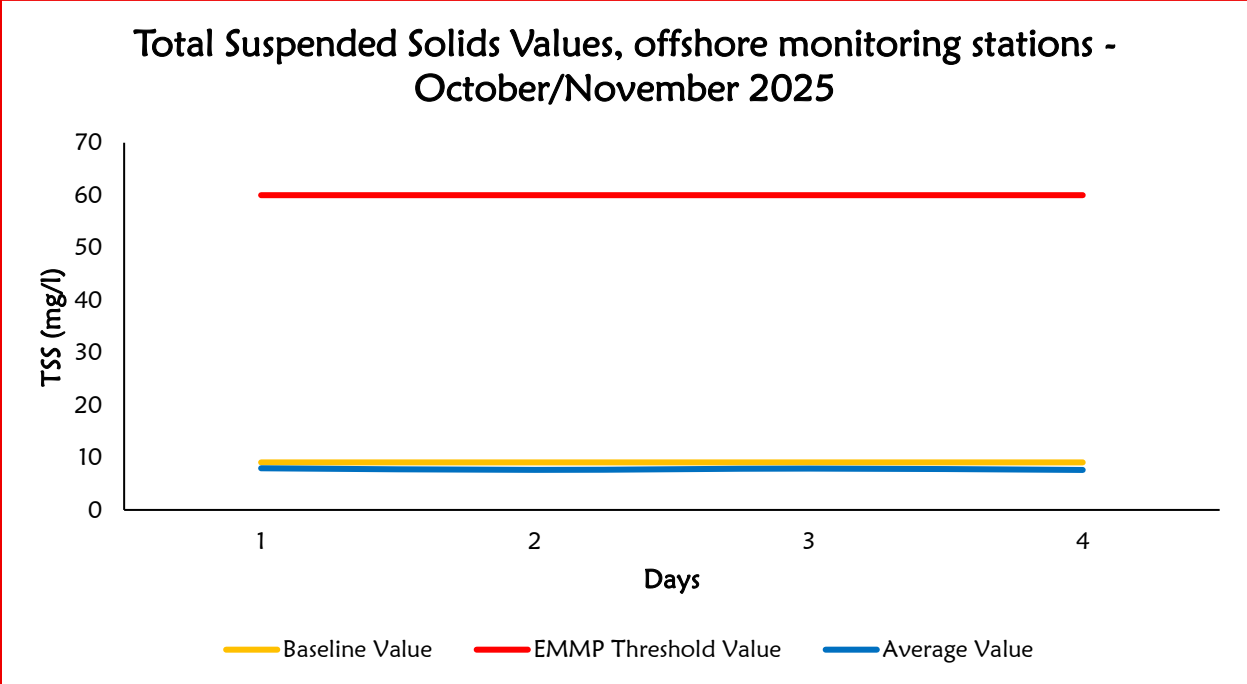
Figure 2: Total Suspended Solid values for inshore and offshore monitoring stations for the month of October/November 2025. The average value is the mean TSS at -0.5m, -3.0m and -8.0m for onshore and offshore monitoring stations (Data source: Lahvens Limited, October/November 2025).

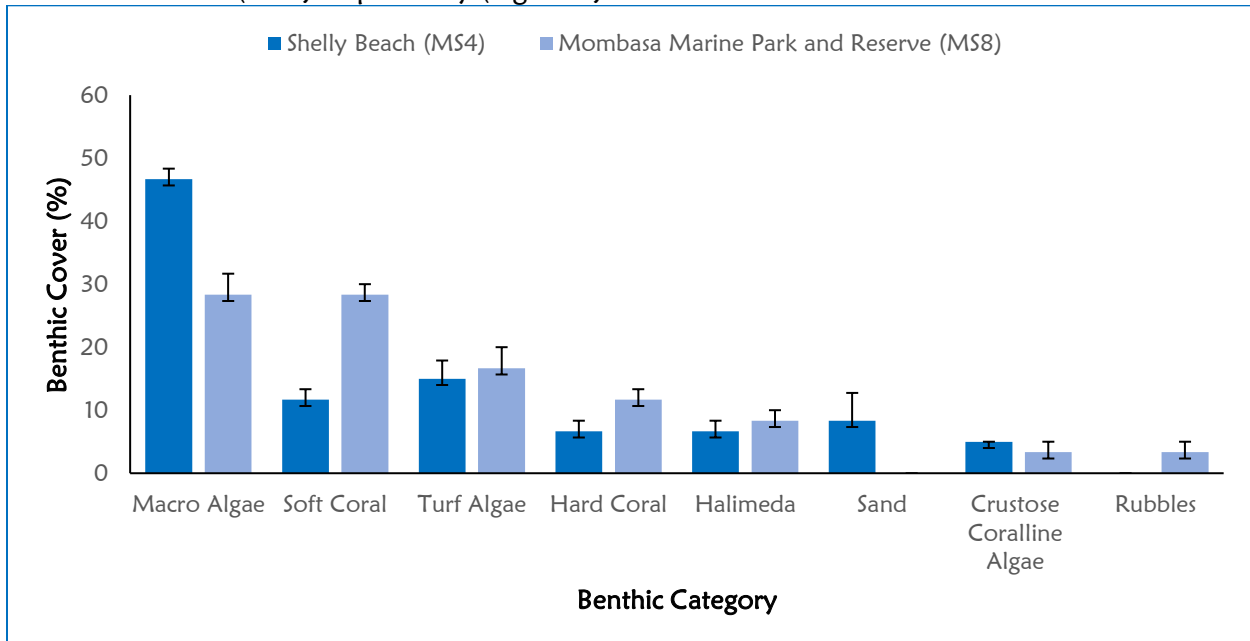
Figure 3: Benthic substrate characteristics at Shelly Beach (MS4) and Mombasa Marine Park and Reserve (MS8) (Source: Envasses, October 2025)

Macro algae (28.3% ± 3.3) and soft corals (28.3% ± 1.7) were the dominant substrate types at Mombasa Marine Park and Reserve (MS8) while Shelly Beach (MS4), was dominated by macro algae (46.7% ± 1.7) and turf algae (15.0% ± 2.9) substrate types. The pronounced dominance of macro algae in both Mombasa Marine Park and Reserve (MS8) and Shelly Beach (MS4), may be attributed to reduced grazing pressure, which allows algae to proliferate and outcompete corals for space and light. The presence of turf algae at both sites, Mombasa Marine Park and Reserve (MS8) (16.7% ± 3.3) and Shelly Beach (MS4) (15.0% ± 2.9), suggests early colonization of degraded substrates previously occupied by soft or hard corals, potentially signaling a gradual shift away from healthy coral-dominated reef states. Corals at Shelly Beach (MS4) show signs of physical damage likely linked to increased fishing activity associated with the seasonal shift from the South East Monsoon (SEM) to the North East Monsoon (NEM), when calmer sea conditions favor artisanal fisheries. This is evidenced by visible scratch marks on the corals and a noticeable rise in the number of set gears in the area (Figure 4). In total, eight coral genera were identified across both sites. Sand cover (3.3% ± 1.7) was only recorded at Shelly Beach (MS4). Sand (8.3% ± 4.4)

and rubble (3.3 ± 1.7) substrates were only recorded at Shelly Beach (MS4) and Mombasa Marine Park and Reserve (MS8) respectively (Figure 3).

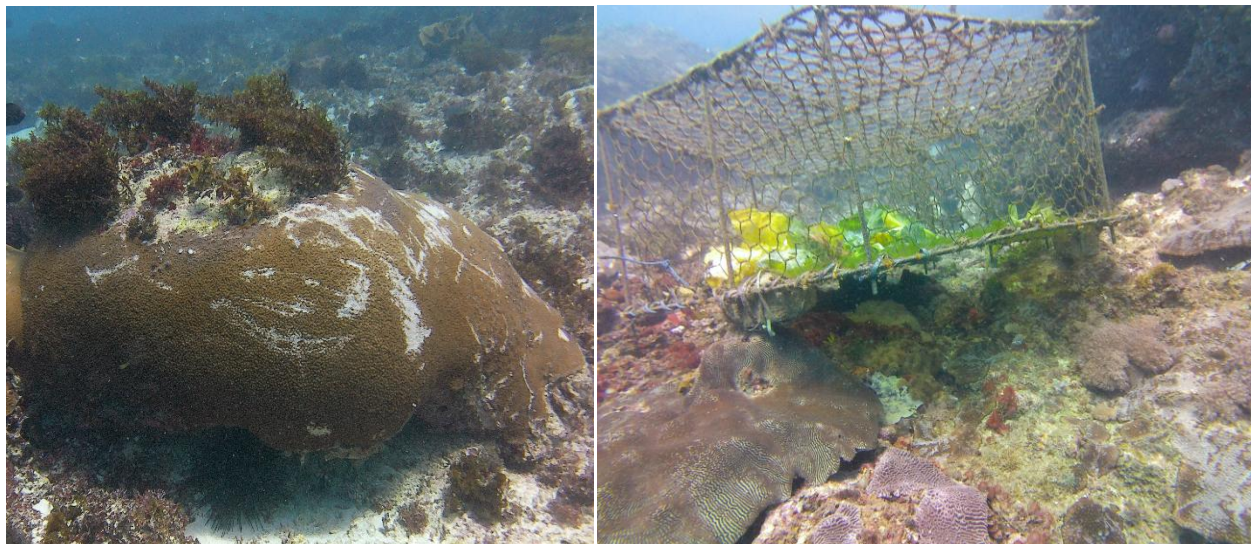
Figure 4: Scratch marks on a hard coral boulder (left) and basket trap set on corals at Shelly Beach (MS4) (Source: Envasses, October 2025)

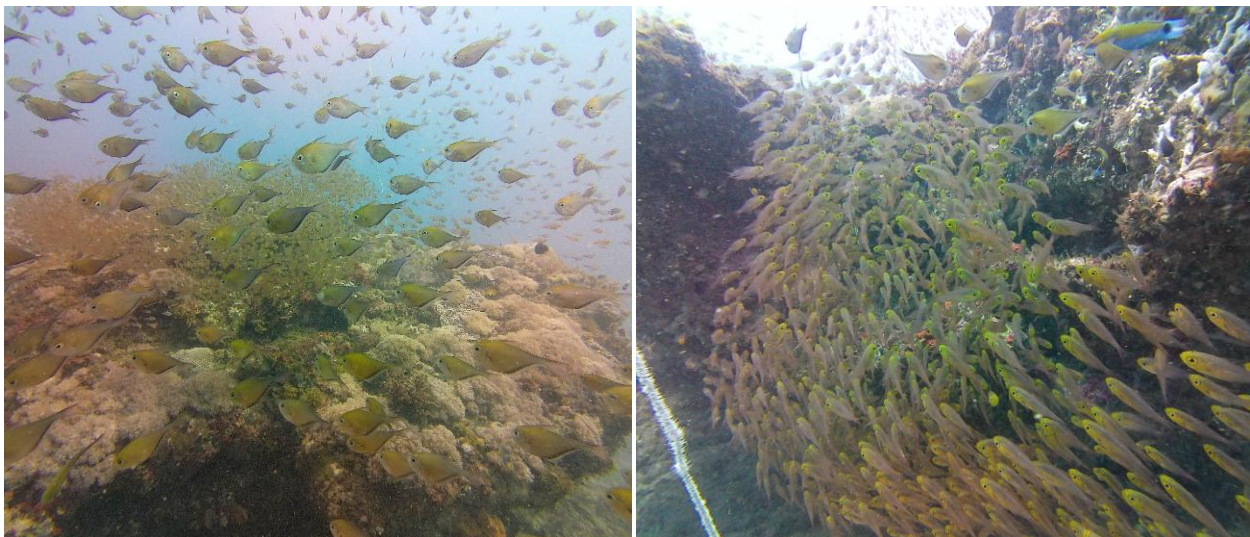
Figure 6: Fish fingerlings and juveniles at Mombasa Marine Park and Reserve (MS8) (Source: Envasses, October 2025)

individ. /250m²) and Lutjanidae (16.0 ± 3.1 individ. /250m²) were the most abundant families at Mombasa Marine Park and Reserve (MS8) while in Shelly Beach (MS4), Labridae (8.3 ± 1.8 individ. /250m²) and Acanthuridae (6.7 ± 0.9 individ. /250m²) were the most abundant. Three common indicators of reef health such as Acanthuridae, Chaetodontidae and Scaridae fish families were present at both monitoring stations in low densities. Both Mombasa Marine Park and Reserve (MS8) and Shelly Beach (MS4) recorded low densities of planktivorous family, Acanthuridae, 10.7 ± 1.2 individ. /250m² and 6.7 ± 0.9 individ. /250m² respectively (Figure 5). Sighting of thousands of fish fingerlings and juveniles concentrated at a single point at Mombasa Marine Park and Reserve (MS8) signifies a rich nursery habitat, recent or ongoing spawning events, and seasonal recruitment pulse (Figure 6).

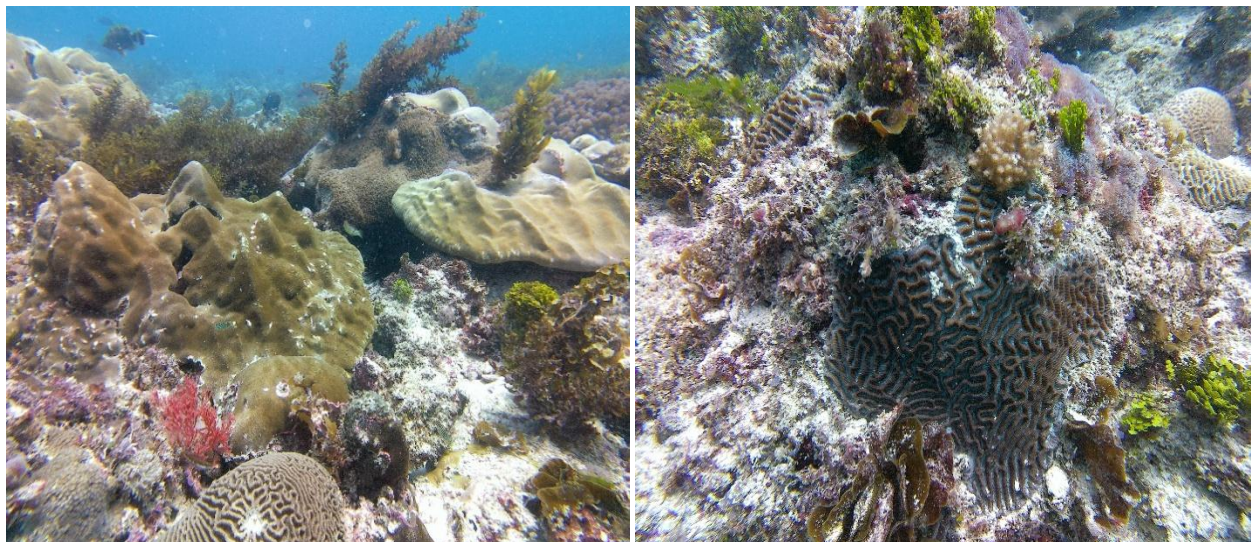
Figure 10: Coral reef area getting dominated by macro algae and turf algae (left) and dying coral patches (right) at Shelly Beach (MS4) (Source: Envasses, November 2025)

ecological pressures, including reduced herbivory, fishing activity and nutrient enrichment. Coral cover remains comparatively higher at Mombasa Marine Park and Reserve, while Shelly Beach continues to show signs of coral stress and localized degradation. Fish and invertebrate assemblages similarly highlight healthier, more diverse communities within the Mombasa Marine Park and Reserve relative to Shelly Beach, where lower densities and signs of ecological disturbance, particularly elevated sea urchin populations, suggest ongoing anthropogenic and natural pressures. The sighting of endangered species such as Black Sea cucumber (*Holothuria atra*) in both monitoring stations underscores the ecological value of the surveyed areas and the continued need for implementing environmental mitigation measures throughout the project cycle. The findings from this monitoring period show no significant deviation from baseline conditions and confirm that project activities remain within acceptable environmental performance targets.

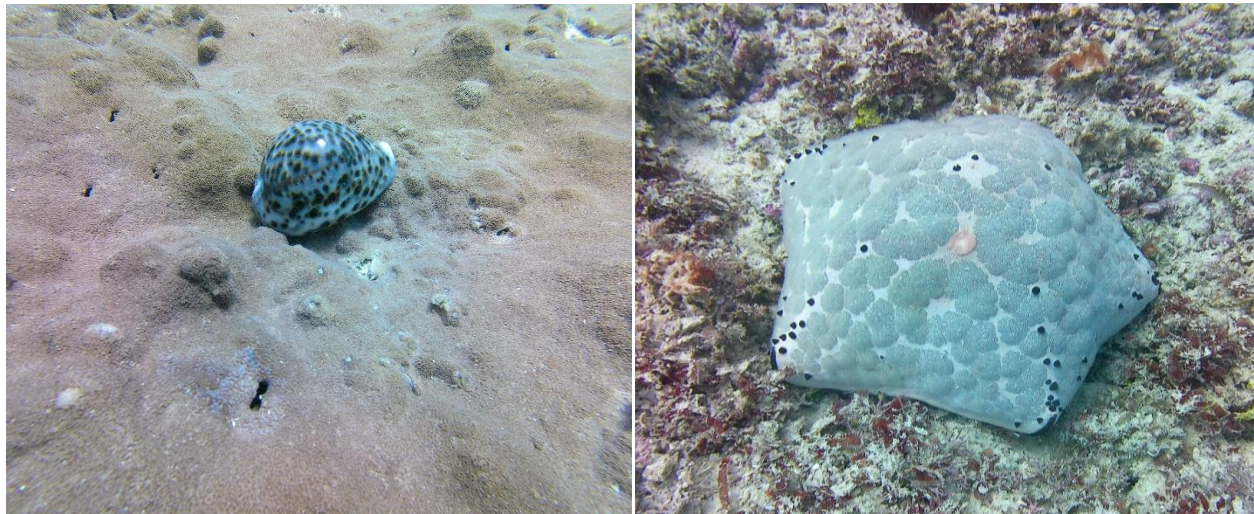
Figure 14: Cypraeidae (*Cypraea tigris*) at Mombasa Marine Park and Reserve (MS8) (left) and Oreasteridae (*Culcita novaeguineae*) at Shelly Beach (MS4) (right) (Source: Envasses, November 2025)
