CHINA COMMUNICATIONS CONSTRUCTION COMPANY
CCCC CONSTRUCTION OF BERTH 19B AND ASSOCIATED
INFRASTRUCTURE

ENGINEERING, PROCUREMENT AND CONSTRUCTION OF BERTH 19B AND ASSOCIATED INFRASTRUCTURE TENDER NO. KPA/004/2024-2025/PDM	DOCUMENT NO. CCCC/BERTH 19B/EMP/05
5TH MONTHLY ENVIRONMENTAL MONITORING REPORT 20TH November – 19TH December 2025	A1

5TH MONTHLY ENVIRONMENTAL MONITORING REPORT

Environmental Management and Monitoring Plan for Civil and Construction Works at Mombasa Port Berth 19B and Associated Infrastructure

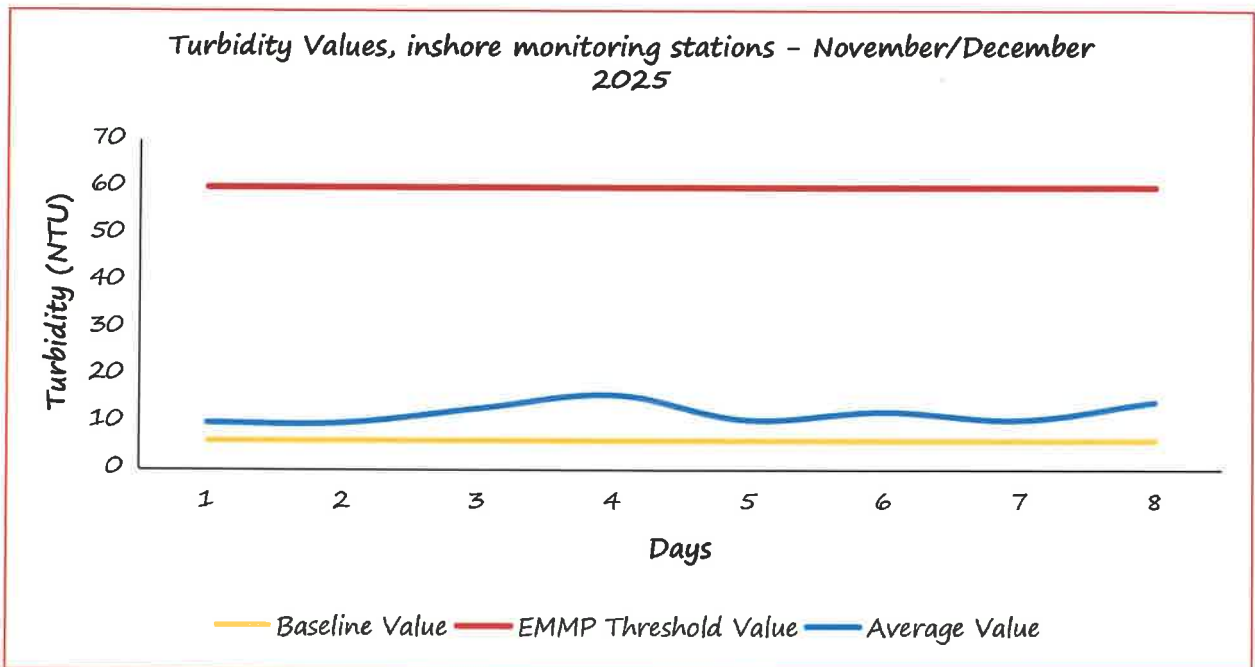
Figure 1: Turbidity values for onshore and offshore monitoring stations for the month of November/December 2025. The average value is the mean turbidity at -0.5m, -3.0m and -8.0m for the inshore and offshore monitoring stations (Data source: Lahvens Limited, November/December 2025).

This section presents the results for water quality monitoring for both the inshore monitoring stations (MS1-3) and offshore monitoring stations (MS4-8) for the monthly report period. These are summarized in Table 1 and 2 below and the summary of the raw data pooled for both the inshore and offshore monitoring stations for the entire month (Table 3). Both the physical water quality parameters i.e. pH, Dissolved Oxygen (DO) and turbidity, and the chemical water quality parameters i.e. Total Suspended Solids (TSS), Chemical Oxygen Demand (COD) and Perspective Degree were reported. Offshore monitoring stations reported insignificant change in parameters and the records are within the EMMP threshold value. All the inshore and offshore results are within the EMMP threshold values (Figure 1 and 2).

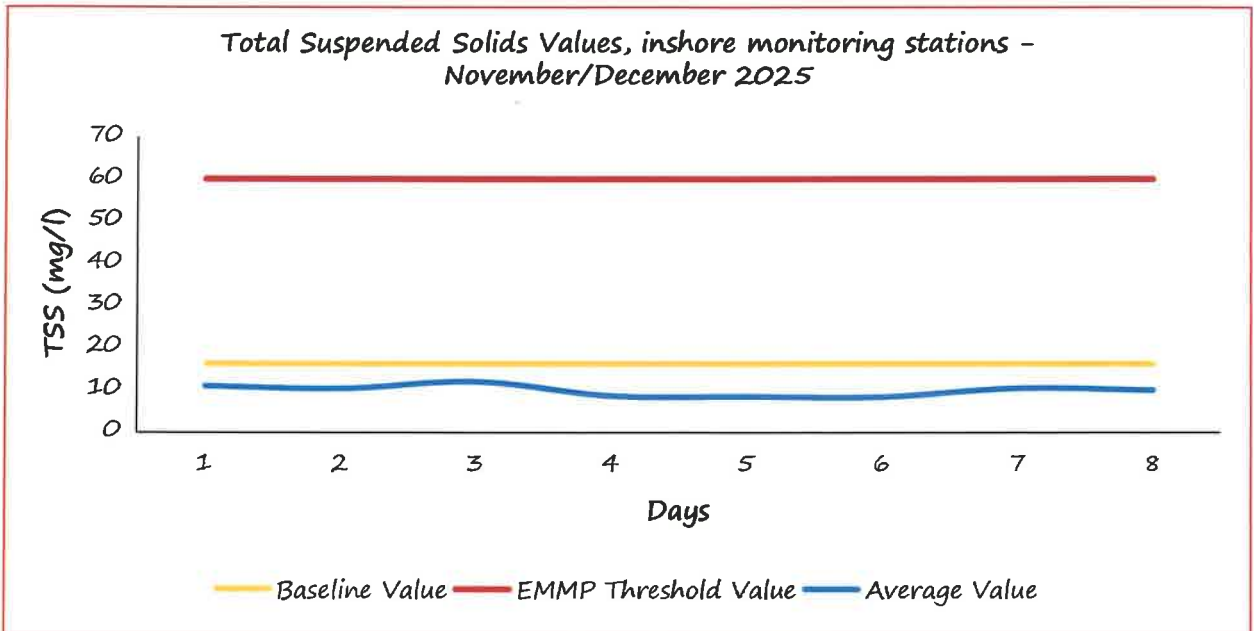
Figure 2: Total Suspended Solid values for inshore and offshore monitoring stations for the month of November/December 2025. The average value is the mean TSS at -0.5m, -3.0m and -8.0m for onshore and offshore monitoring stations (Data source: Lahvens Limited, November/December 2025).

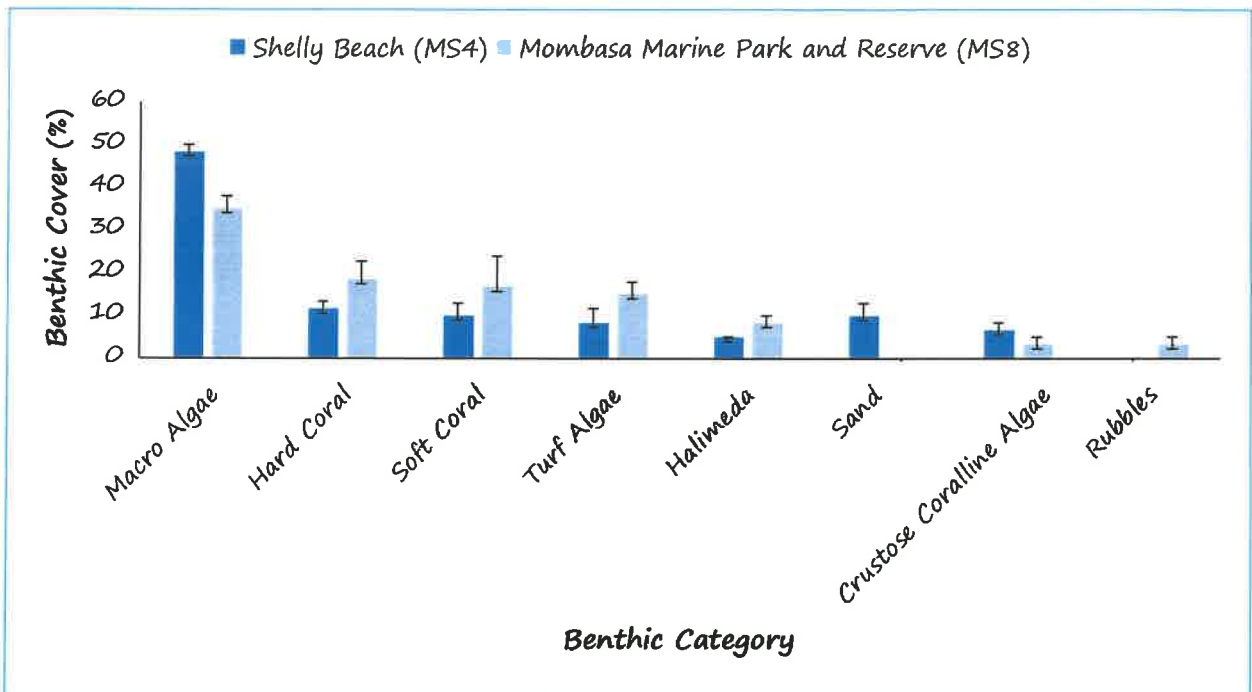
Macro algae (35.0% ± 2.9; 48.3% ± 1.7), hard corals (18.3% ± 4.4; 11.7% ± 1.7) and soft corals (16.7% ± 7.3; 10.0% ± 2.9) were the dominant substrate types at Mombasa Marine Park and Reserve (MS8), and Shelly Beach (MS4) respectively. The pronounced dominance of macro algae in both Mombasa Marine Park and Reserve (MS8) and Shelly Beach (MS4), may be attributed to reduced grazing pressure, which allows algae to proliferate and outcompete corals for space and light. The presence of turf algae at both sites, Mombasa Marine Park and Reserve (MS8) (15.0% ± 2.9) and Shelly Beach (MS4) (8.3% ± 3.3), suggests early colonization of degraded substrates previously occupied by soft or hard corals, potentially signaling a gradual shift away from healthy coral-dominated reef states. Corals at Shelly Beach (MS4) show signs of physical damage likely linked to increased fishing activity associated with the seasonal shift from the South East Monsoon (SEM) to the North East Monsoon (NEM), when calmer sea conditions favor artisanal fisheries. This is evidenced by visible scratch marks on the corals and a noticeable rise in the number of set gears in the area. In total, eight coral genera were identified across both sites. Sand cover (10.0% ± 2.9) and rubble (3.3% ± 1.7) substrates were only recorded at Shelly Beach (MS4) and Mombasa Marine Park and Reserve (MS8) respectively (Figure 3).

Figure 3: Benthic substrate characteristics at Shelly Beach (MS4) and Mombasa Marine Park and Reserve (MS8) (Source: Envasses, November 2025)

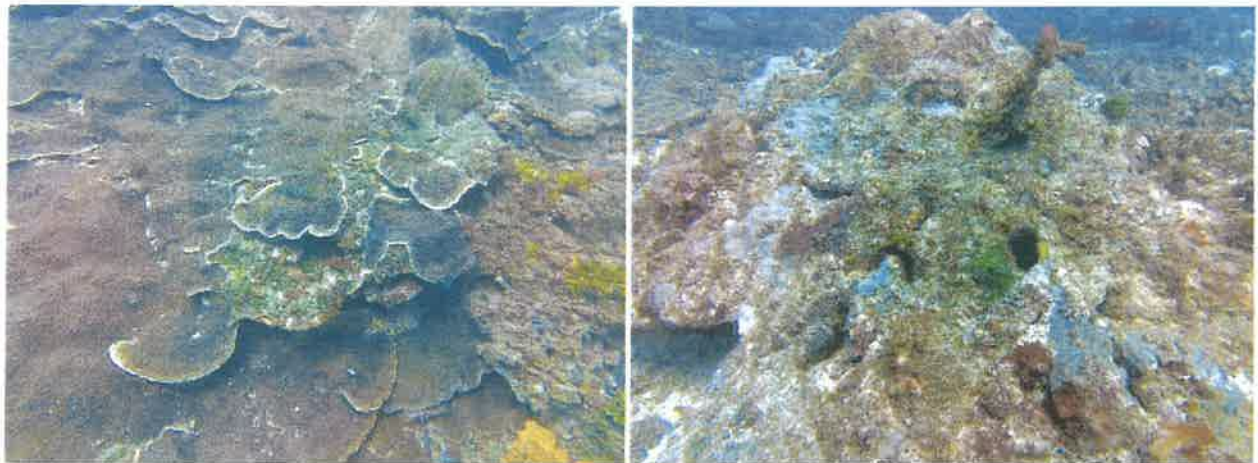
Figure 4: Healthy coral reef (left) and degraded coral reef (right) at Mombasa Marine Park and Reserve (MS8) and Shelly Beach (MS4) respectively (Source: Envasses, November 2025)

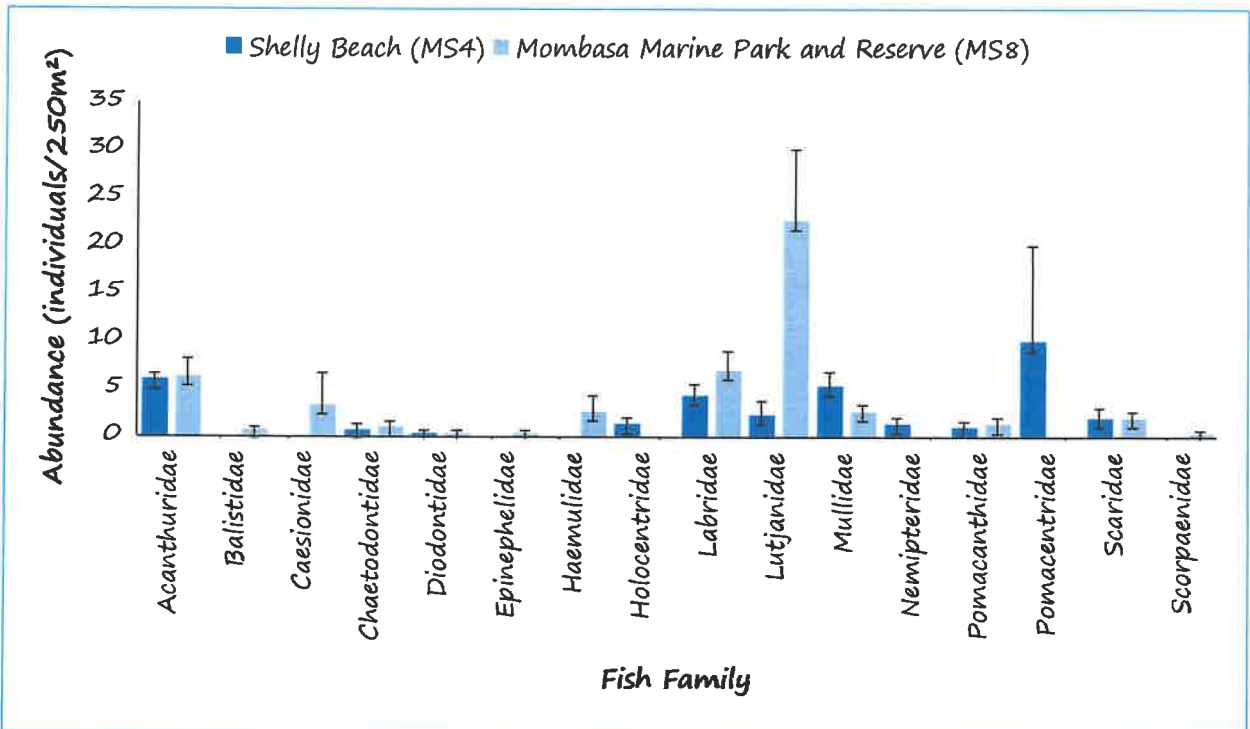
A total of 34 species were recorded from both Mombasa Marine Park and Reserve (24 species) and Shelly Beach (18 species). Mombasa Marine Park and Reserve (MS8) exhibited a relatively high fish density (22.7 ± 7.4 indiv. /250m²), indicating a richer and more diverse fish assemblage compared to Shelly Beach (MS4) which recorded low fish density of 10.0 ± 0.0 indiv. /250m² as maximum density. A total of 16 fish families were recorded from both Mombasa Marine Park and Reserve (13 fish families) and Shelly Beach (11 fish families). Lutjanidae (22.7 ± 7.4 indiv. /250m²) and Pomacentridae (10.0 ± 0.0 indiv. /250m²) were the most abundant families at Mombasa Marine Park and Reserve (MS8) and Shelly Beach (MS4) respectively. Three common indicators of reef health such as Acanthuridae, Chaetodontidae and Scaridae fish families were present at both monitoring stations in low densities. Both Mombasa Marine Park and Reserve (MS8) and

Shelly Beach (MS4) recorded low densities of planktivorous family, Acanthuridae, 6.3 ± 1.9 indiv. /250m² and 6.0 ± 0.6 indiv. /250m² respectively (Figure 5). Sighting of thousands of fish fingerlings and juveniles concentrated at a single point at Mombasa Marine Park and Reserve (MS8) signifies a rich nursery habitat, recent or ongoing spawning events, and seasonal recruitment pulse (Figure 6).

Figure 5: Fish species density at Shelly Beach (MS4) and Mombasa Marine Park and Reserve (MS8) (Source: Envasses, November 2025)

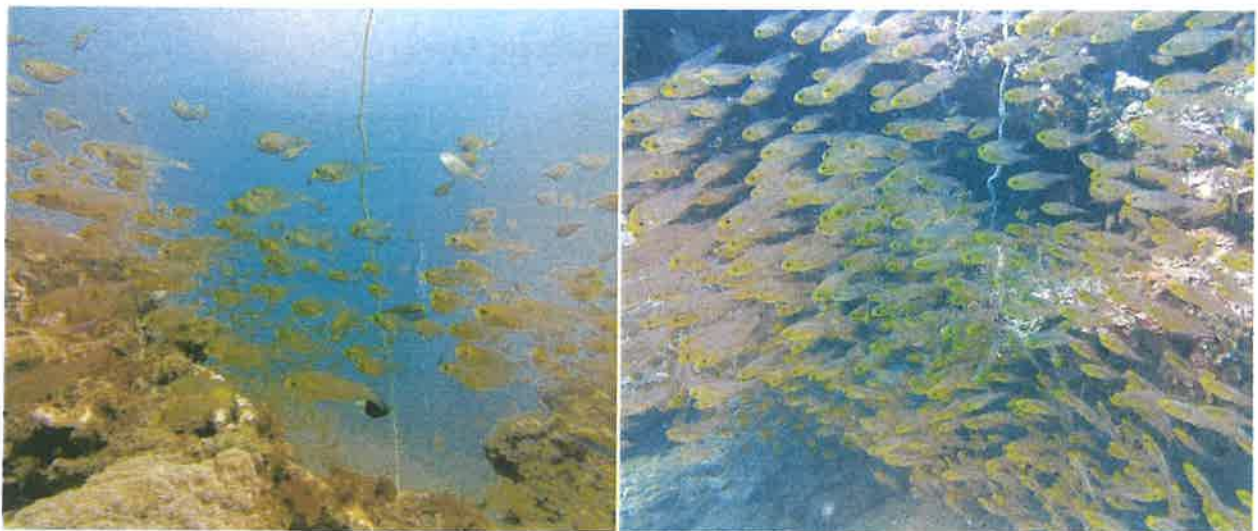
Figure 6: Fish fingerlings and juveniles at Mombasa Marine Park and Reserve (MS8) (Source: Envasses, November 2025)

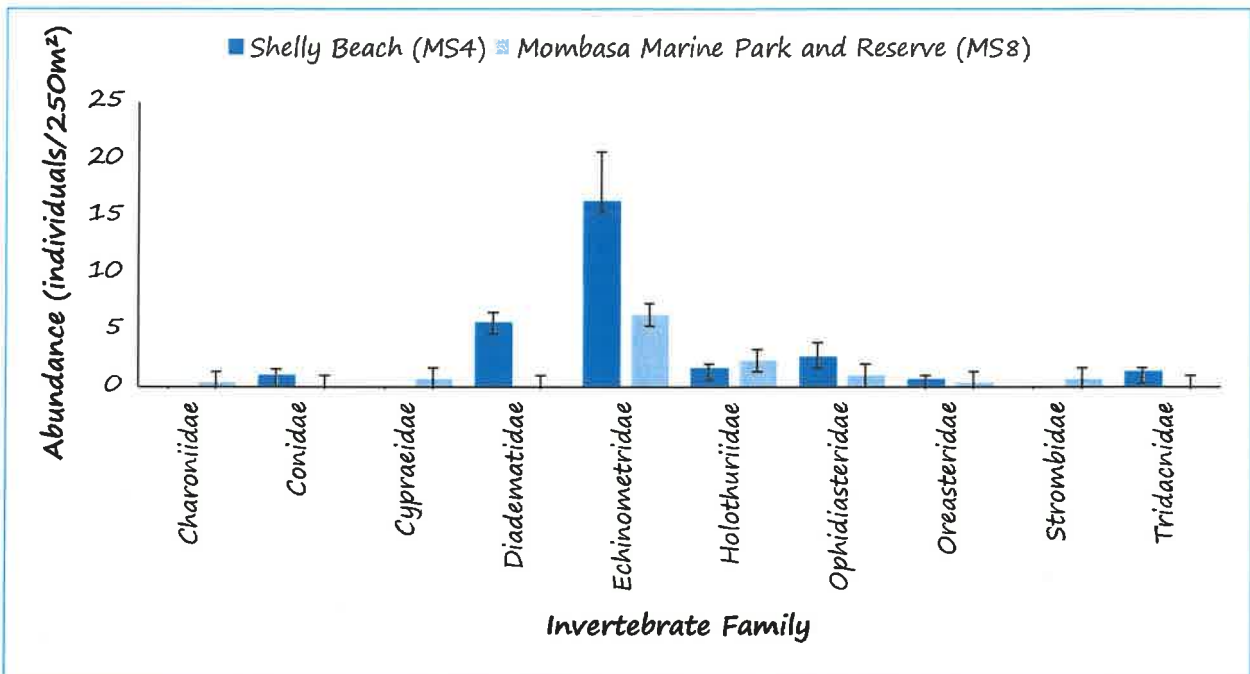
Ten (10) invertebrates' taxa were observed at both Mombasa Marine Park and Reserve (7 taxa) and Shelly Beach (7 taxa). Echinometridae dominated both Mombasa Marine Park and Reserve (6.3 ± 1.9 indiv. /250m²) and Shelly Beach (16.3 ± 4.3 indiv. /250m²). The Echinometridae (*Echinostrephus molaris*) dominance primarily signifies heavy fishing pressure on their natural predators and can lead to the significant degradation of coral reefs. Charoniidae (0.3 ± 0.3 indiv. /250m²), Cypraeidae (0.7 ± 0.3 indiv. /250m²) and Strombidae (0.7 ± 0.3 indiv. /250m²) were only recorded in Mombasa Marine Park and Reserve (MS8), while Shelly Beach (MS4) recorded Conidae (1.0 ± 0.6 indiv. /250m²), Diadematidae (5.7 ± 0.9 indiv. /250m²) and Tridacnidae (1.3 ± 0.3 indiv. /250m²) in very low densities. (Figure 7). This may signify a stressed or environmentally disturbed ecosystem, often linked to overfishing, reduced fish populations that prey on urchins, and the potential for increased bioerosion in both monitoring stations.

Figure 7: Invertebrates density at Shelly Beach (MS4) and Mombasa Marine Park and Reserve (MS8) (Source: Envasses, November 2025)

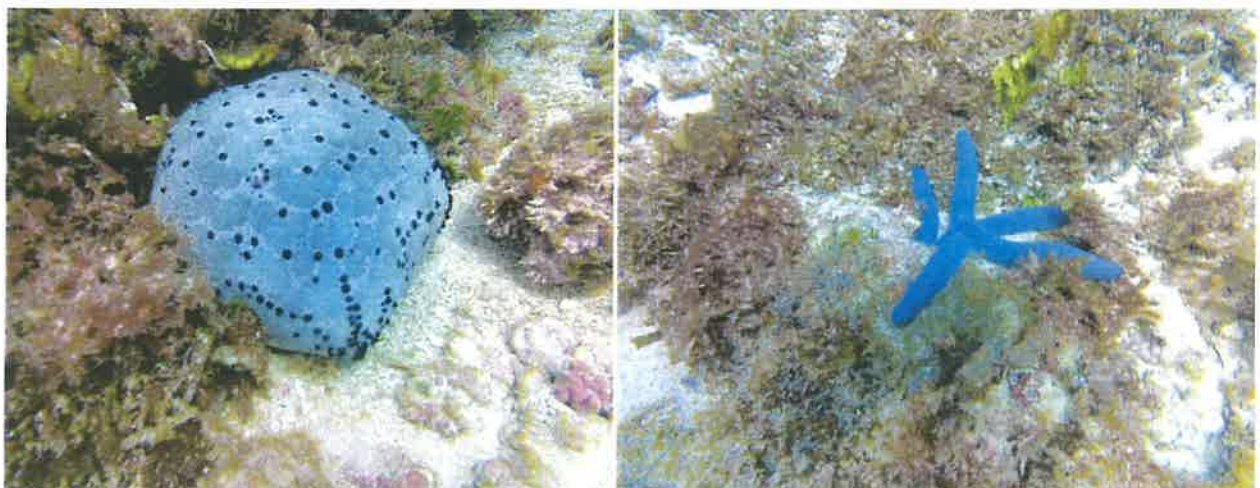
Figure 8: Oreasteridae (*Culcita novaeguineae*) (left) and Ophiasteridae (*Linckia laevigata*) (right) in Shelly Beach (MS4) (Source: Envasses, November 2025)

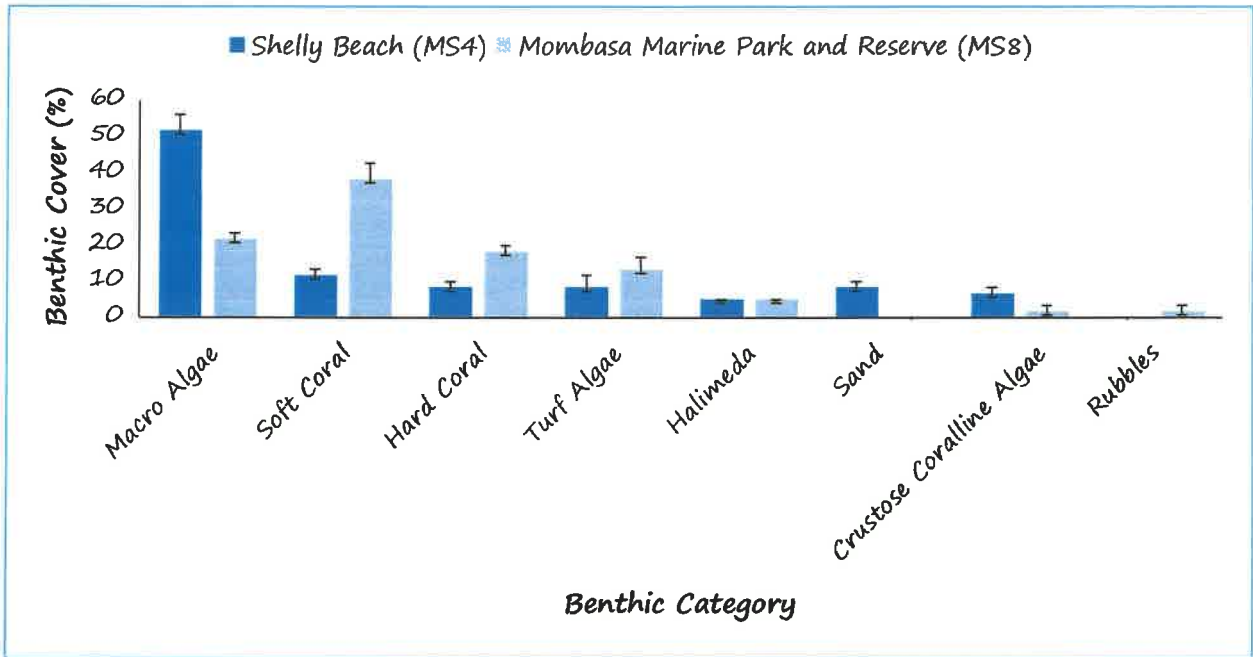
Macro algae (21.7% ± 1.7; 51.7% ± 4.4), soft corals (38.3% ± 4.4; 11.7% ± 1.7), hard corals (18.3% ± 1.7; 8.3% ± 1.7) and turf algae (13.3% ± 3.3; 8.3% ± 3.3) were the dominant substrate types at Mombasa Marine Park and Reserve (MS8), and Shelly Beach (MS4) respectively. The domination of macro algae and the presence of turf algae at both sites, Mombasa Marine Park and Reserve (MS8) (21.7% ± 1.7 and 13.3% ± 3.3 respectively) and Shelly Beach (MS4) (51.7% ± 4.4 and 8.3% ± 3.3 respectively) indicate a decline in coral cover, likely driven by environmental stressors, reduced herbivory, and nutrient enrichment, signaling a potential shift towards an algae-dominated, degraded reef state. Continued coral mortality at Shelly Beach (MS4) is evident by small patches of corals in boulders that were once thriving and increased macro and turf algae colonization in the reef area. Evidence of coral bleaching was also recorded at Shelly Beach (MS4) (Figure 10). Only Eight (8) genera of corals were recorded at both Mombasa Marine Park and

Reserve and Shelly Beach area. The low cover of crustose coralline algae observed at both monitoring stations may indicate reduced herbivory within the reef ecosystem. In the absence of other potential stressors such as sedimentation or high turbidity, which are typically associated with declines in crustose coralline algae, the reduced cover is most likely attributed to limited grazing pressure from herbivorous fish and invertebrates. Sand substrate ($8.3\% \pm 1.7$) and rubbles ($1.7\% \pm 1.7$) were only recorded at Shelly Beach (MS4) and Mombasa Marine Park and Reserve (MS8) respectively (Figure 9).

Figure 9: Benthic substrate characteristics at Shelly Beach (MS4) and Mombasa Marine Park and Reserve (MS8) (Source: Envasses, December 2025)

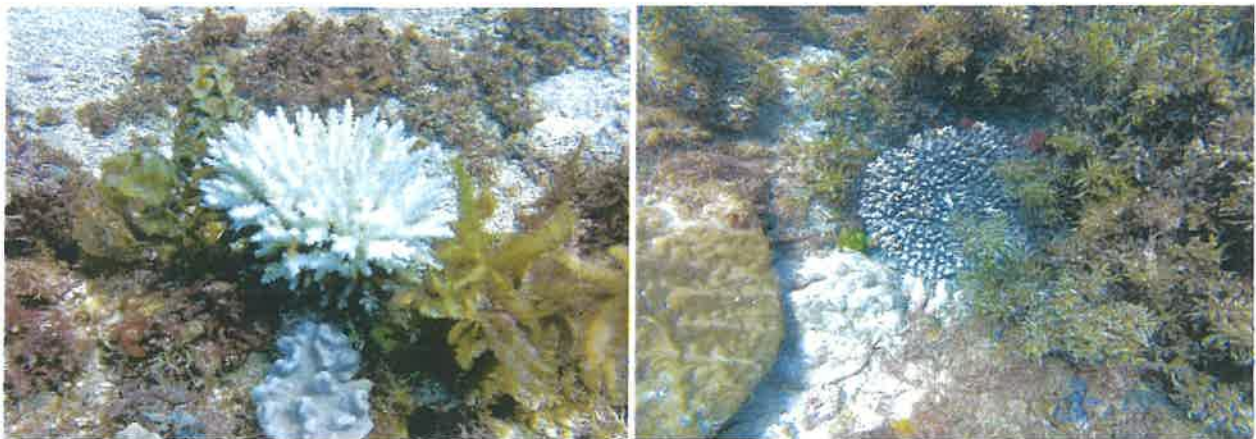
Figure 10: Bleached Acropora coral (left) and completely dead coral (right) at Shelly Beach (MS4) (Source: Envasses, December 2025)

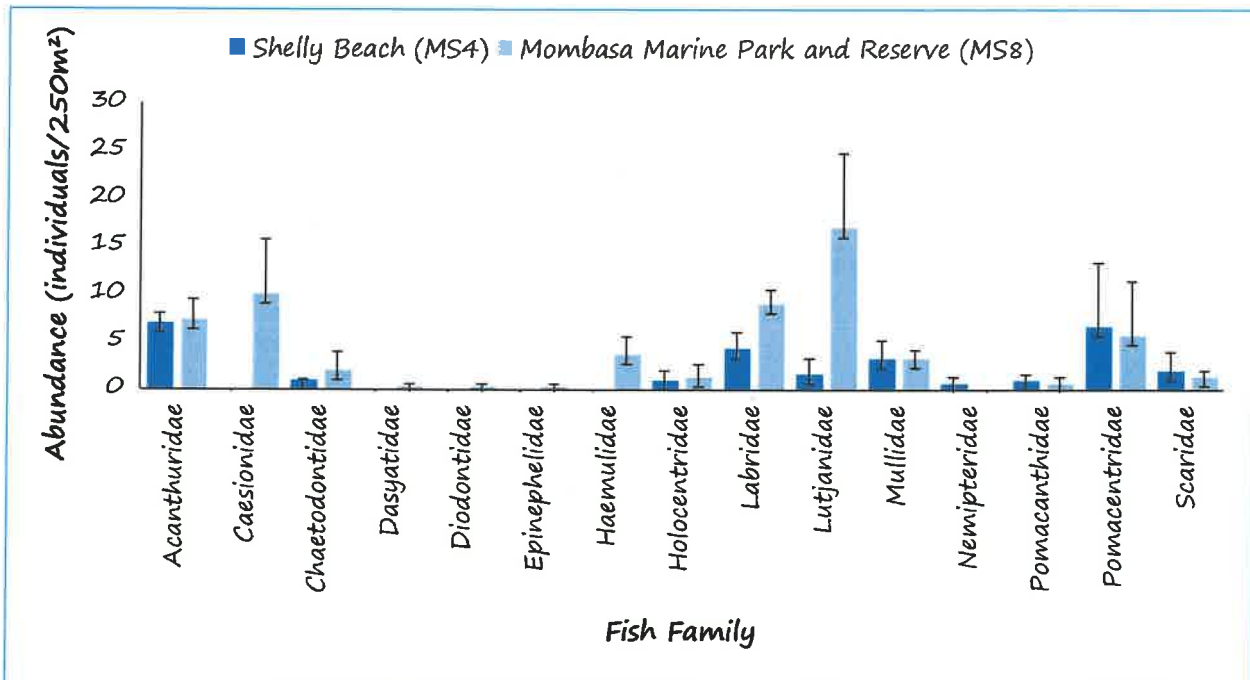
A total of 41 species were recorded from both Mombasa Marine Park and Reserve (34 species) and Shelly Beach (16 species). Mombasa Marine Park and Reserve (MS8) recorded high fish density (17.0 ± 7.8 indiv. / 250m^2) while Shelly Beach (MS4) recorded relatively low fish density

of 7.0 ± 1.0 indiv. /250m² as maximum density. A total of 15 fish families were recorded from both Mombasa Marine Park and Reserve (14 fish families) and Shelly Beach (10 fish families). Lutjanidae (17.0 ± 7.8 indiv. /250m²), Caesionidae (10.0 ± 5.8 indiv. /250m²) and Labridae (9.0 ± 1.5 indiv. /250m²) were the most abundant families at Mombasa Marine Park and Reserve (MS8) while Shelly Beach (MS4) was dominated by Acanthuridae (7.0 ± 1.0 indiv. /250m²), Pomacentridae (6.7 ± 6.7 indiv. /250m²) and Labridae (4.3 ± 1.8 indiv. /250m²) respectively. Three common indicators of reef health such as Acanthuridae, Chaetodontidae and Scaridae fish families were present at both monitoring stations but at relatively low density. Mombasa Marine Park and Reserve (MS8) and Shelly Beach (MS4) recorded relatively low densities of planktivorous family Acanthuridae; 7.3 ± 2.2 indiv. /250m² and 7.0 ± 1.0 indiv. /250m²) respectively (Figure 11).

Figure 11: Fish species density at Shelly Beach (MS4) and Mombasa Marine Park and Reserve (MS8) (Source: Envasses, December 2025)

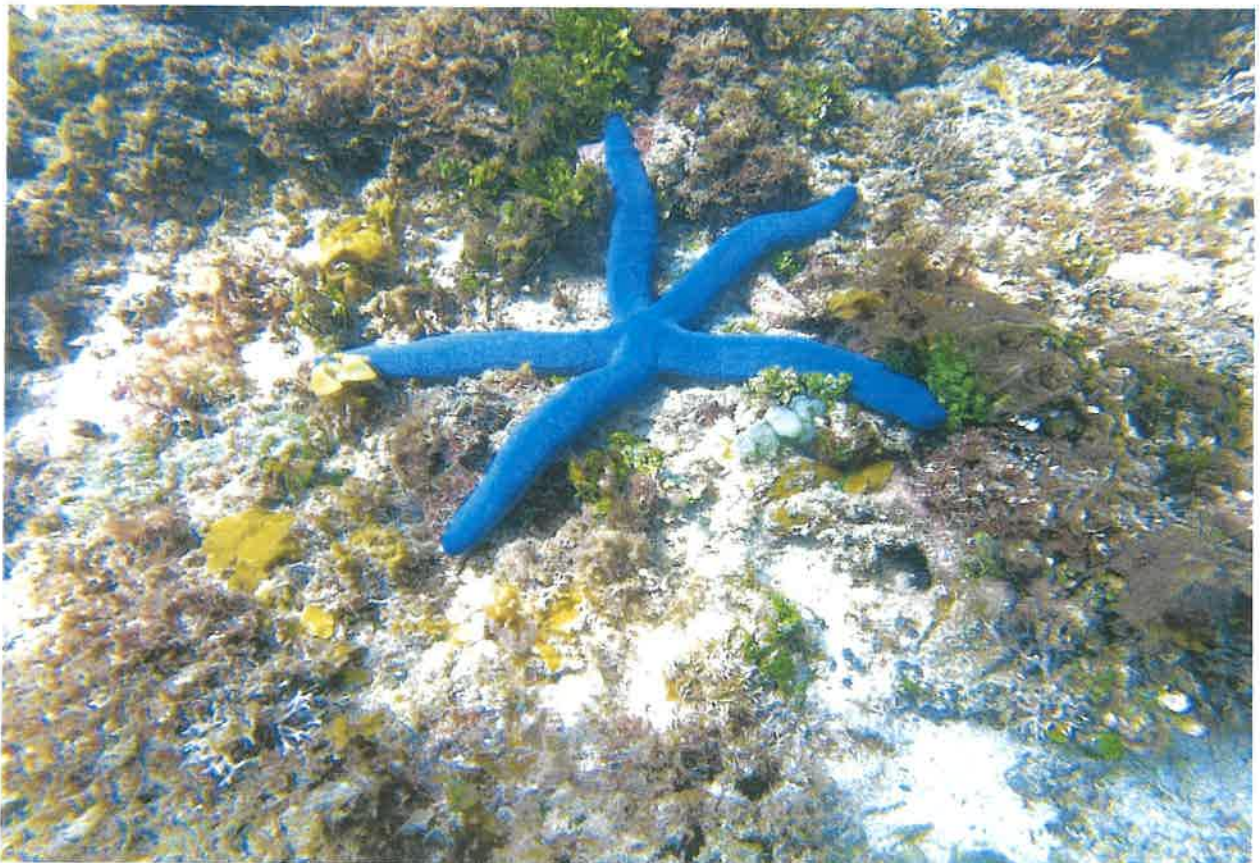
Figure 14: Ophiasteridae (*Linckia laevigata*) at Shelly Beach (MS4) (Source: Envasses, December 2025)
